Re: Public Safety Concerns of Pilot Paddling Program and Dangers of Paddling on the San Lorenzo River.

The eight Hazards are as follows:

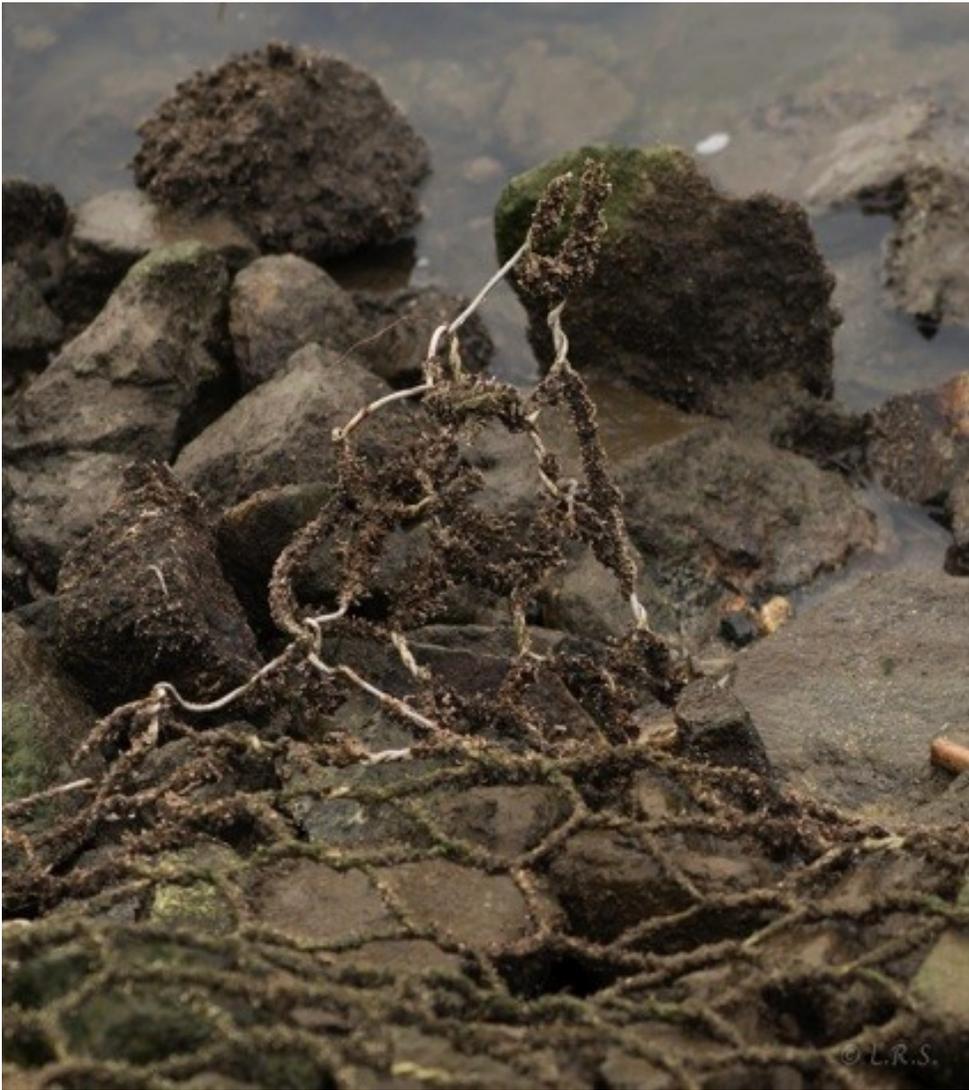
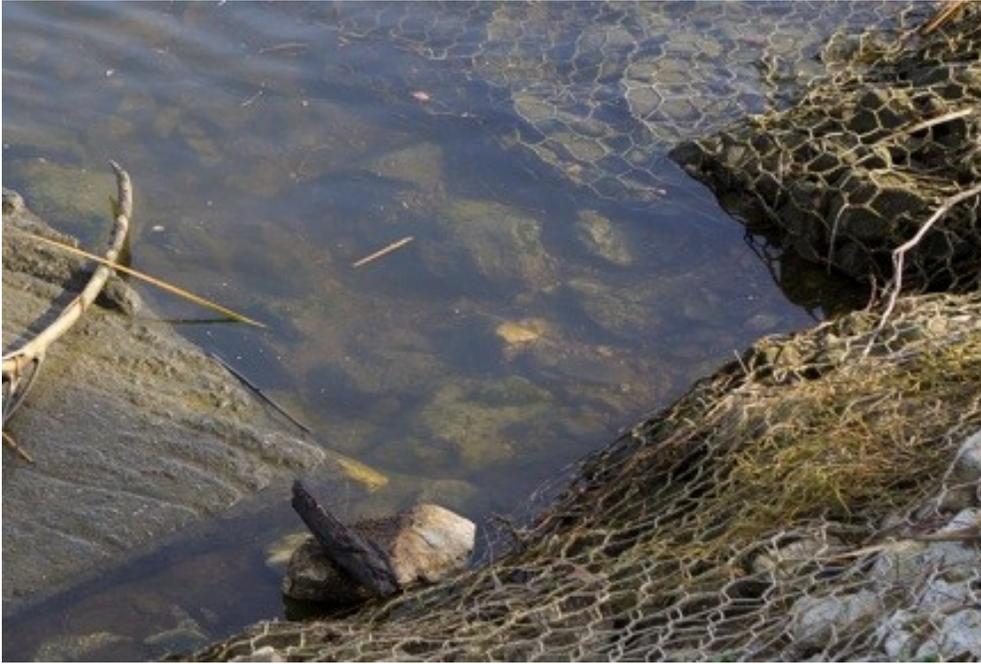
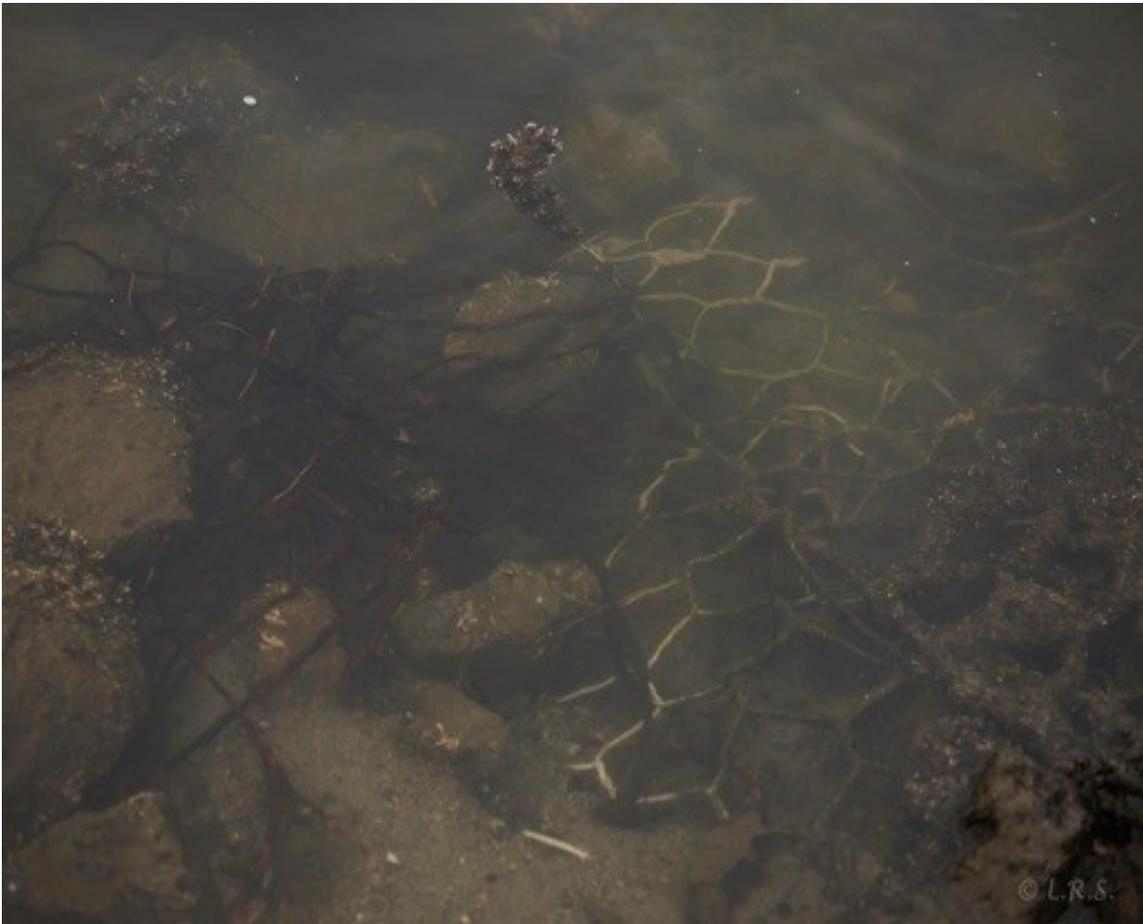
Hazard #1 Gabion Wire Baskets

Hundreds of feet of sharp-edged Gabion wire baskets were used to construct most of the length of the SLR levee system. Designed using twisted wires around rock, the Gabion baskets are dangerous to touch. Over time the wire, exposed to seawater, tends to rust, deteriorate and eventually fail. Baskets lining

the SLR show significant wear and tear, rust, prong protrusion and breakage throughout the proposed Paddle Pilot stretch.

These photos below of exposed wire were taken during low tide. Wires can be seen over many hundreds of feet along the river banks when the tide is low.

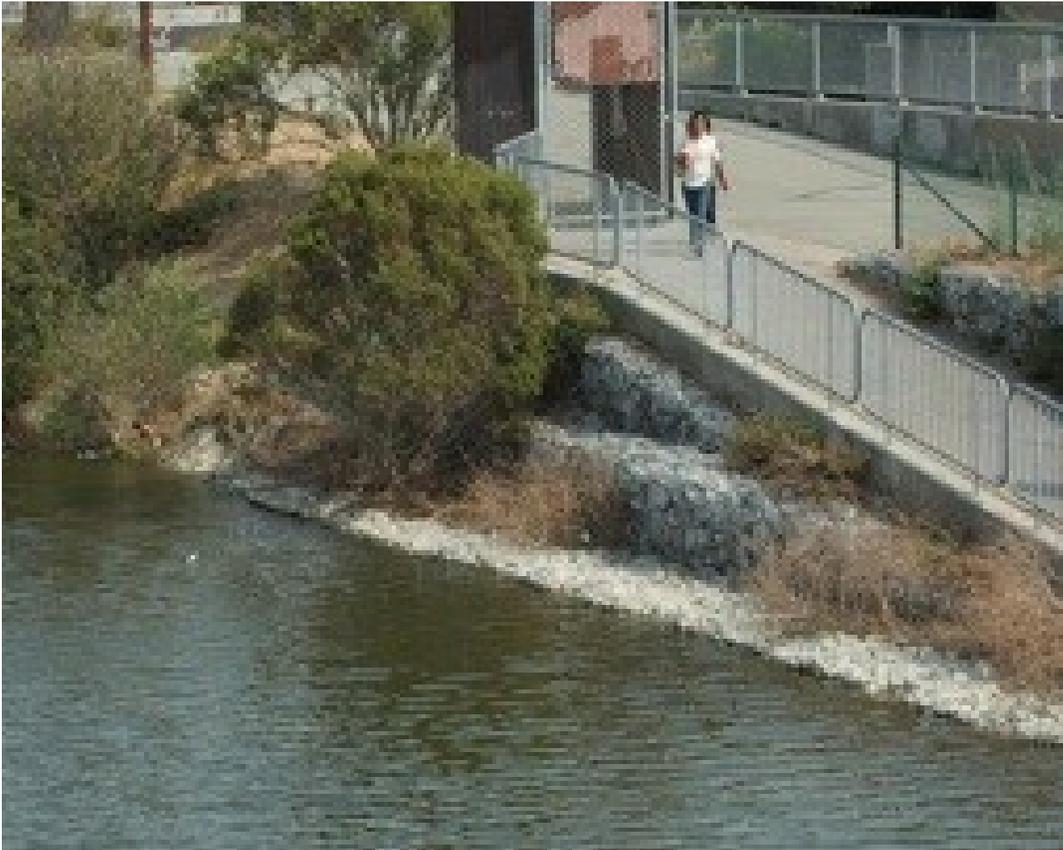
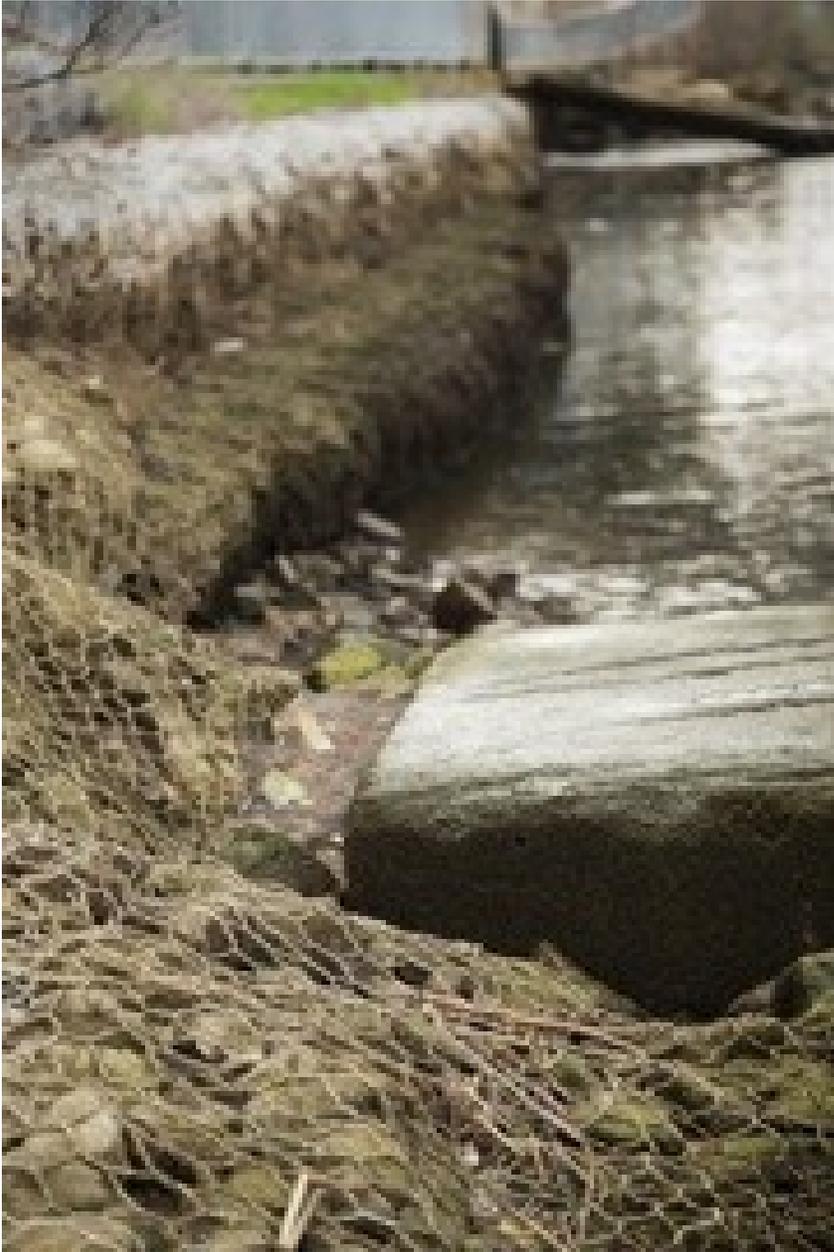
Hazard #2 Concrete blocks, rocks and Gabion wire baskets hidden under water

The concrete blocks and rocks used along the levee banks are invisible during proposed Pilot Paddling Program time line. A fall into the water, with these just below the surface, would easily result in injury to hands, head or body.

The picture below shows how a rock filled, Gabion wire basket wall is hidden under the water. The next picture shows the same concrete wall, facing the opposite direction and how the exposed Gabion wire baskets are just below the surface.

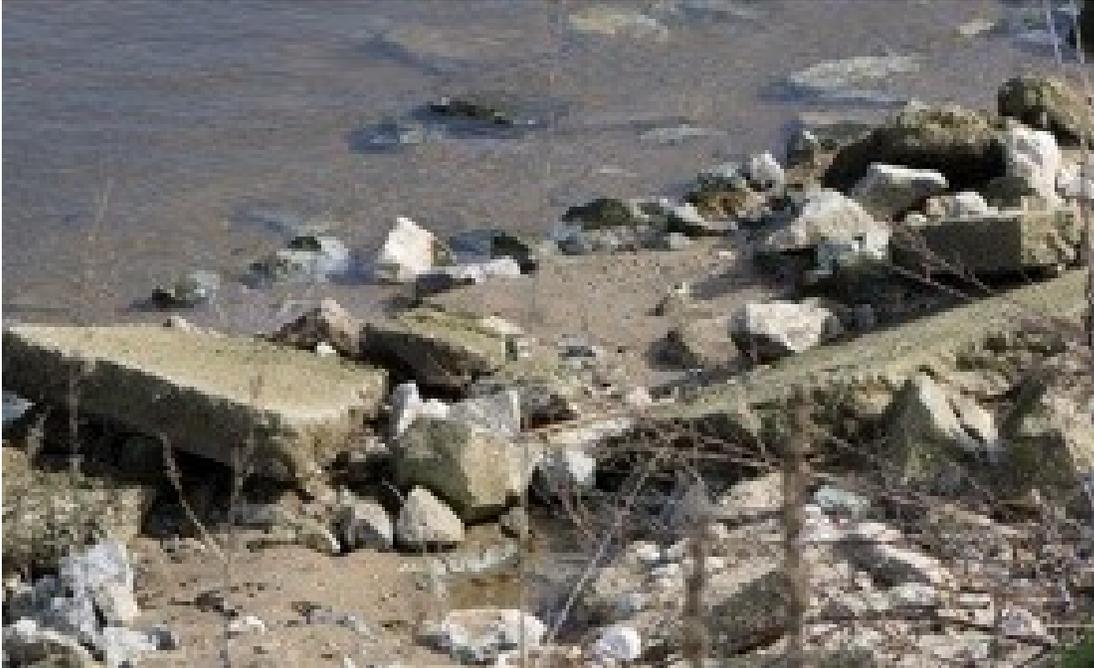
During a closed river mouth, the condition needed for paddling, the water just barely covers these rocks shown above. This can cause a paddler to fall off and harm body and/or vessel.

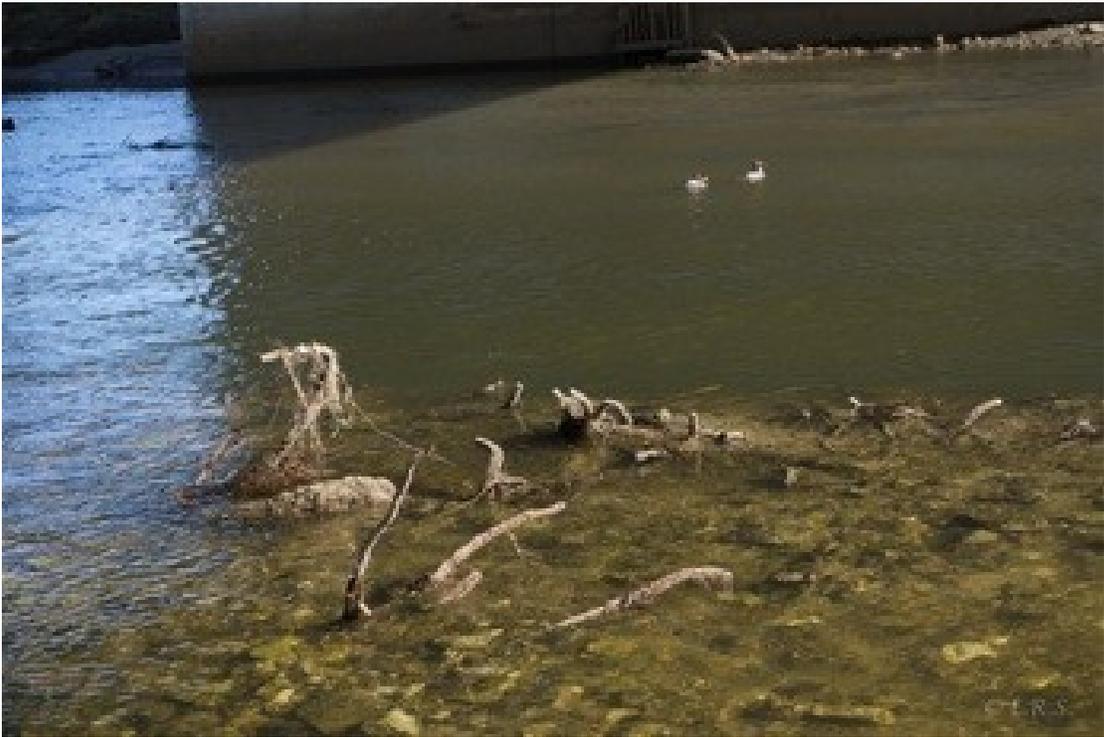
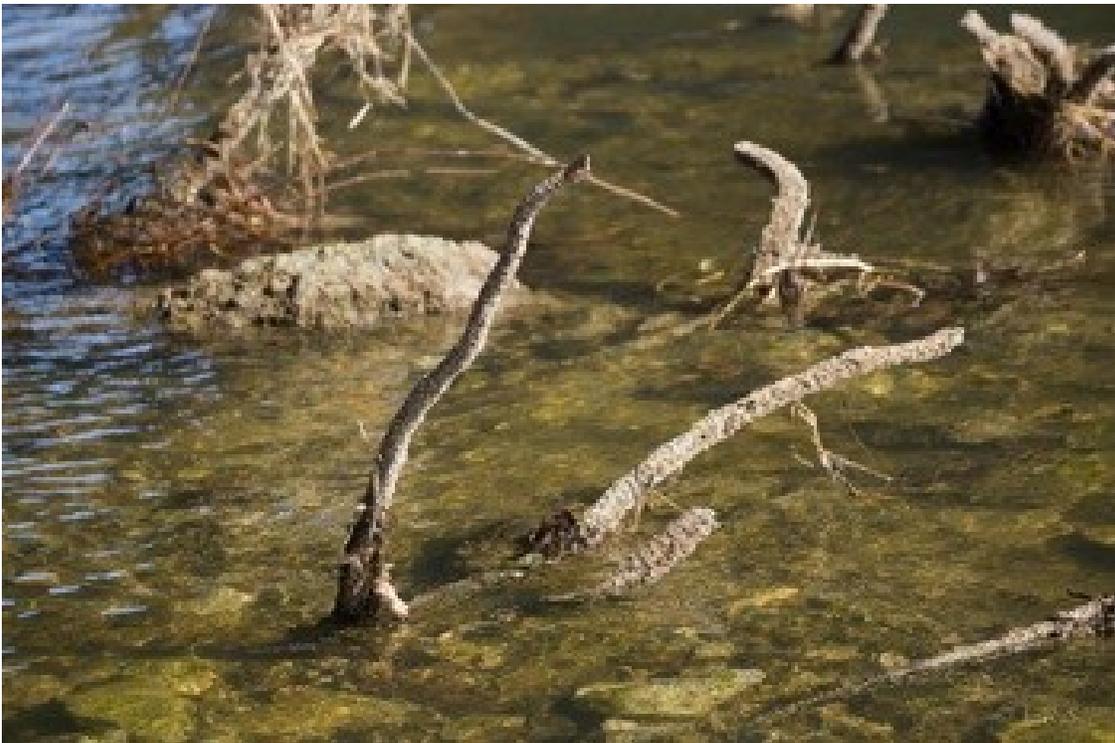
Hazard #3 Remains of old construction material from a previous bridge

During low tide an unknown number of rusted, rebar stakes are viewable under Soquel Ave Bridge. The rebar and several concrete footings are remains from the old bridge. These pose the risk of impaling any paddler or paddle that comes into contact with it.

See photos and Google map below for location on river of this hazard.

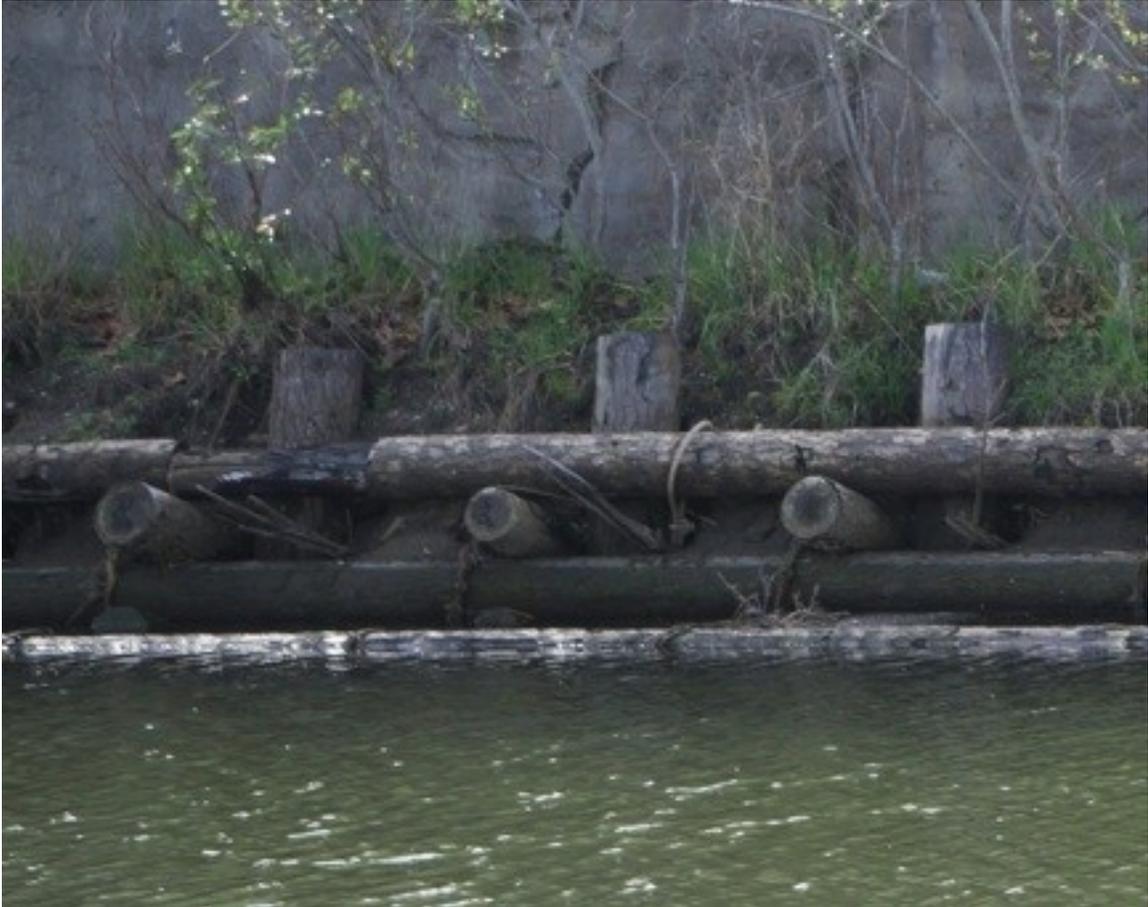
Hazard #4 Wood retaining walls along the Third St. banks

The approximate hundred feet plus of retaining wall along the Third St. Bank is constructed of tree trunks tied with metal, rebar, wire brackets and cable. Falling onto or touching this wall would likely cause head or body injury, splinters or cuts from metal. Paddle board and kayak scrapes and dents are likely due to the sunken tree trunks in front of this wall.

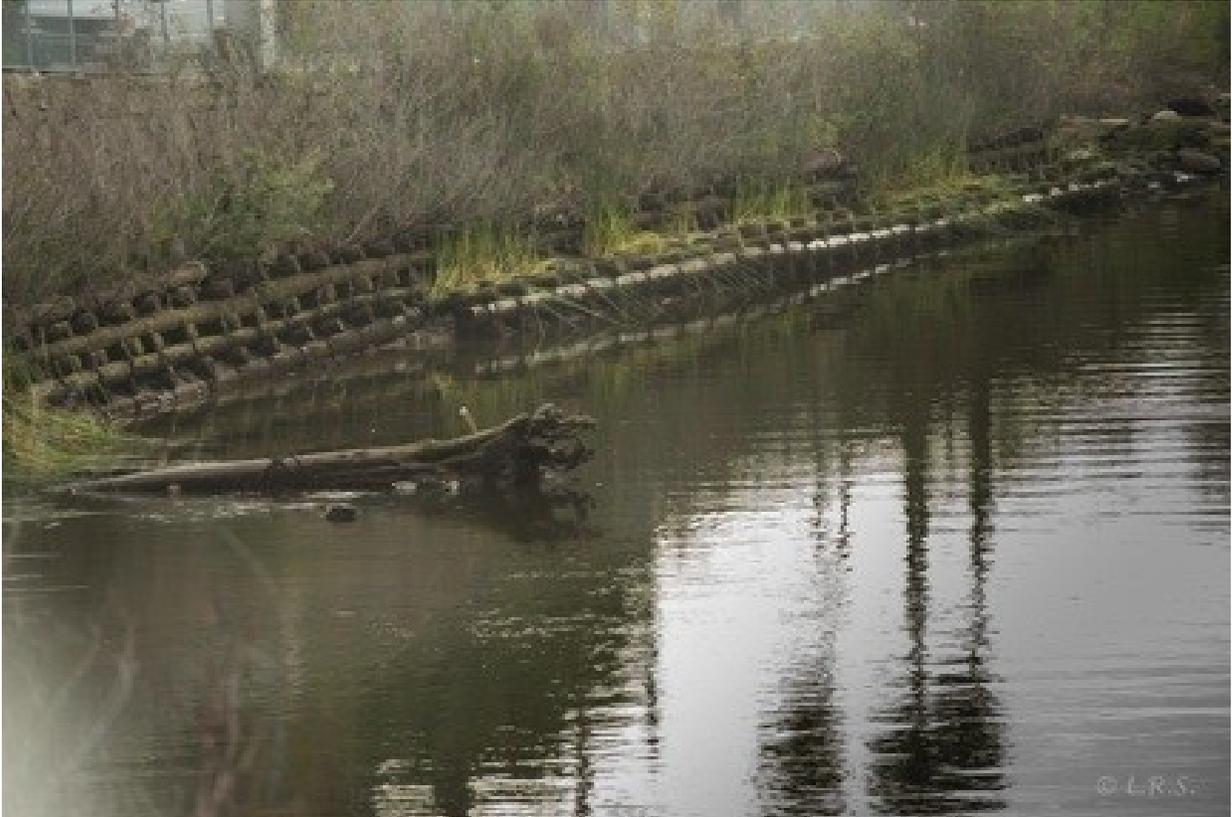
The photo below shows the wood retaining wall and the sunken log trunk for fish habitat. A high tide would cover most of the wall and the sunken log.

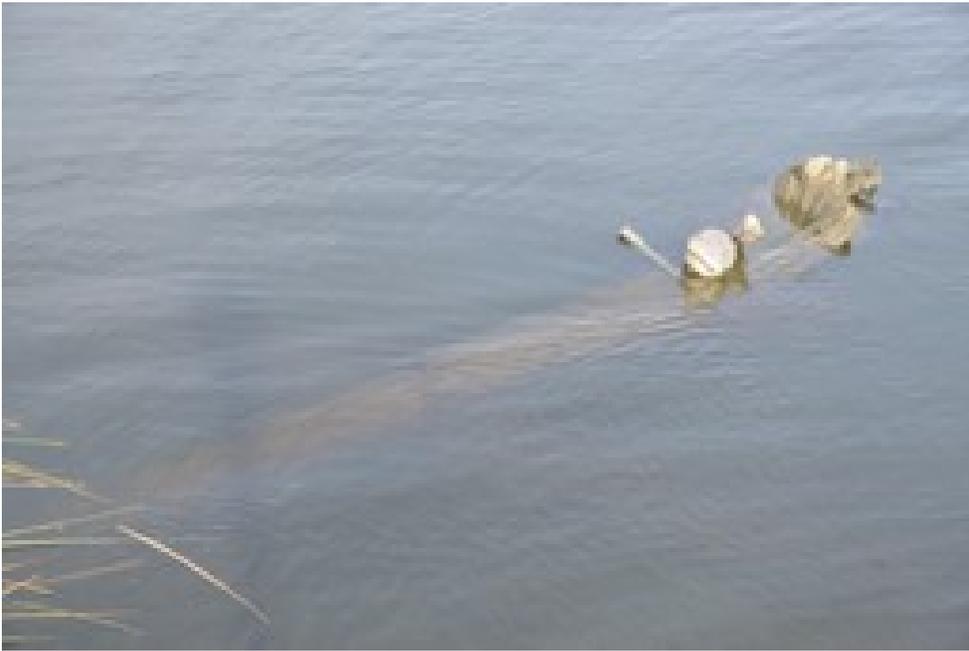
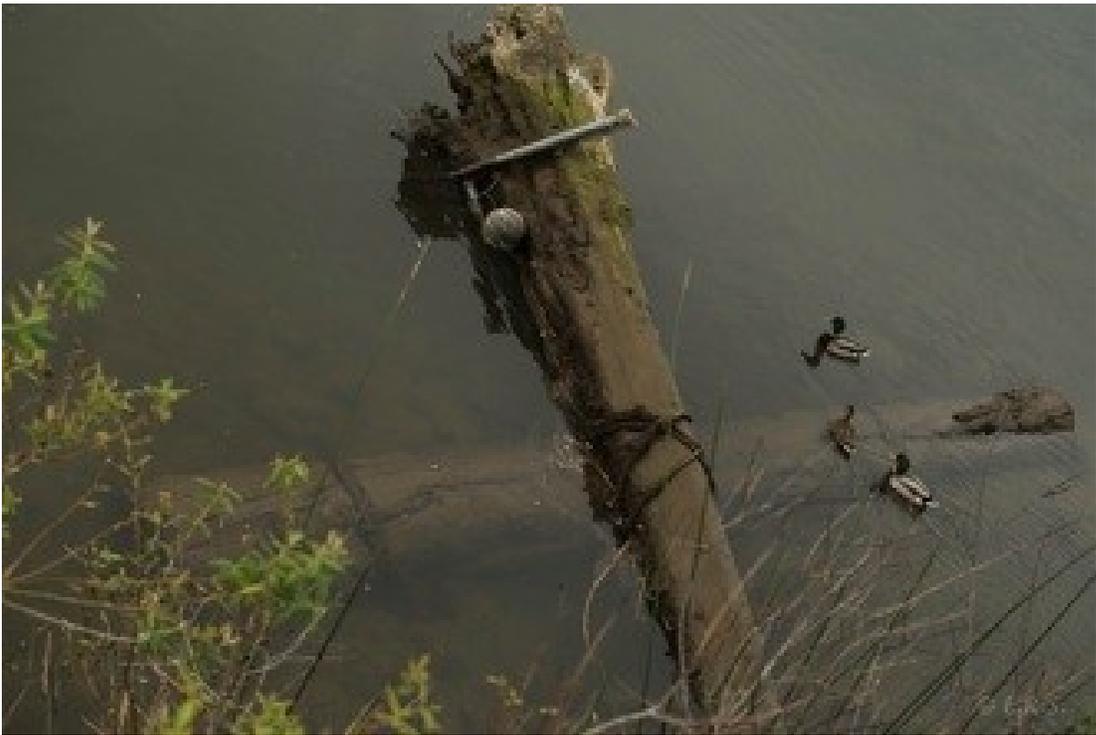
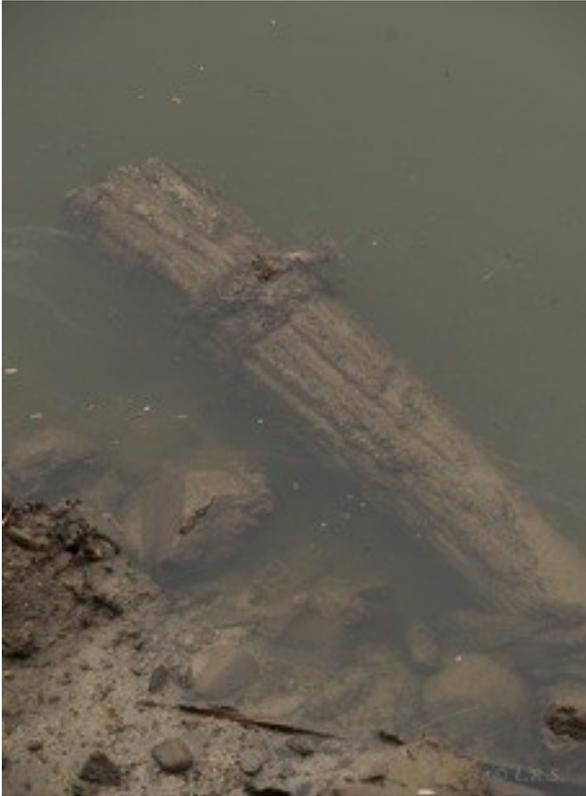
Hazard #5 Fish habitat system of sunken tree logs

At least six large tree logs/trunks are viewable and anchored below the San Lorenzo River to help the fish population.

The location of these logs is approximately between the Third St. stairs, near the Kaiser Permanente Arena and the Riverside Bridge. The exact location, depth and number of tree logs have not been confirmed. One of these logs appears partially unhinged and floating/stuck under the River St. Bridge. Under some conditions, during high tide or murky conditions, this trunk and others are invisible just inches under the water.

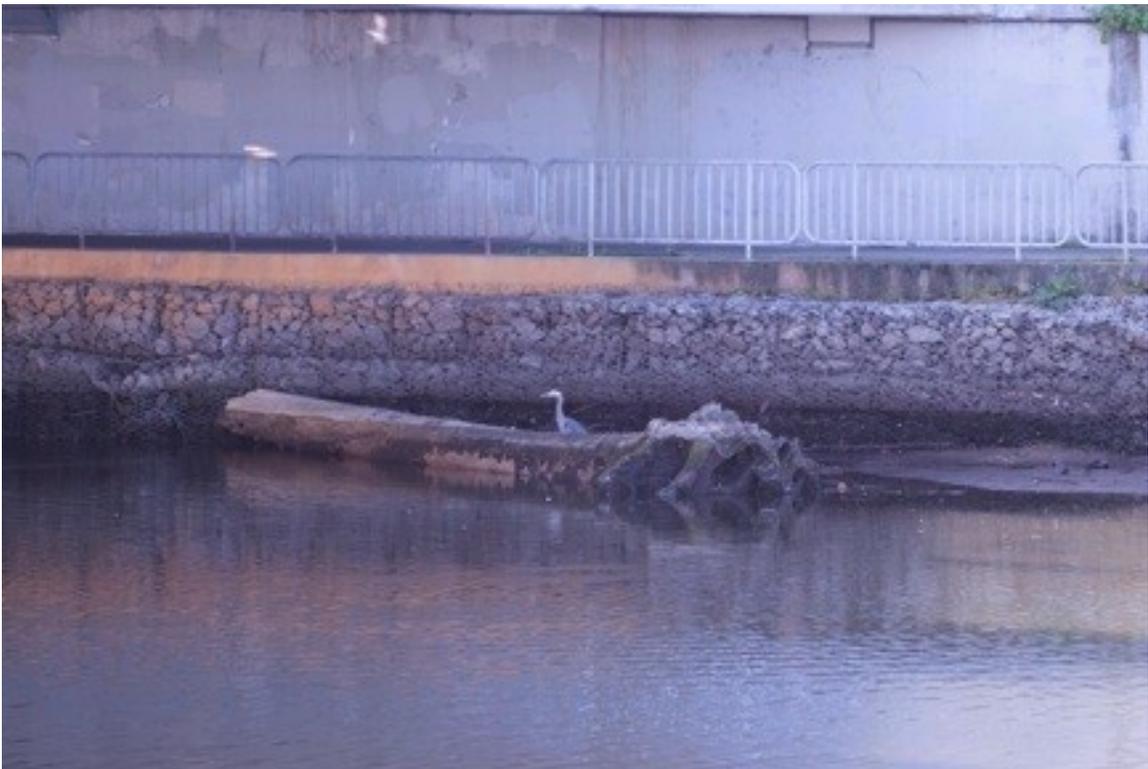
Photo below is a view of a sunken log at low tide under the Riverside Bridge.

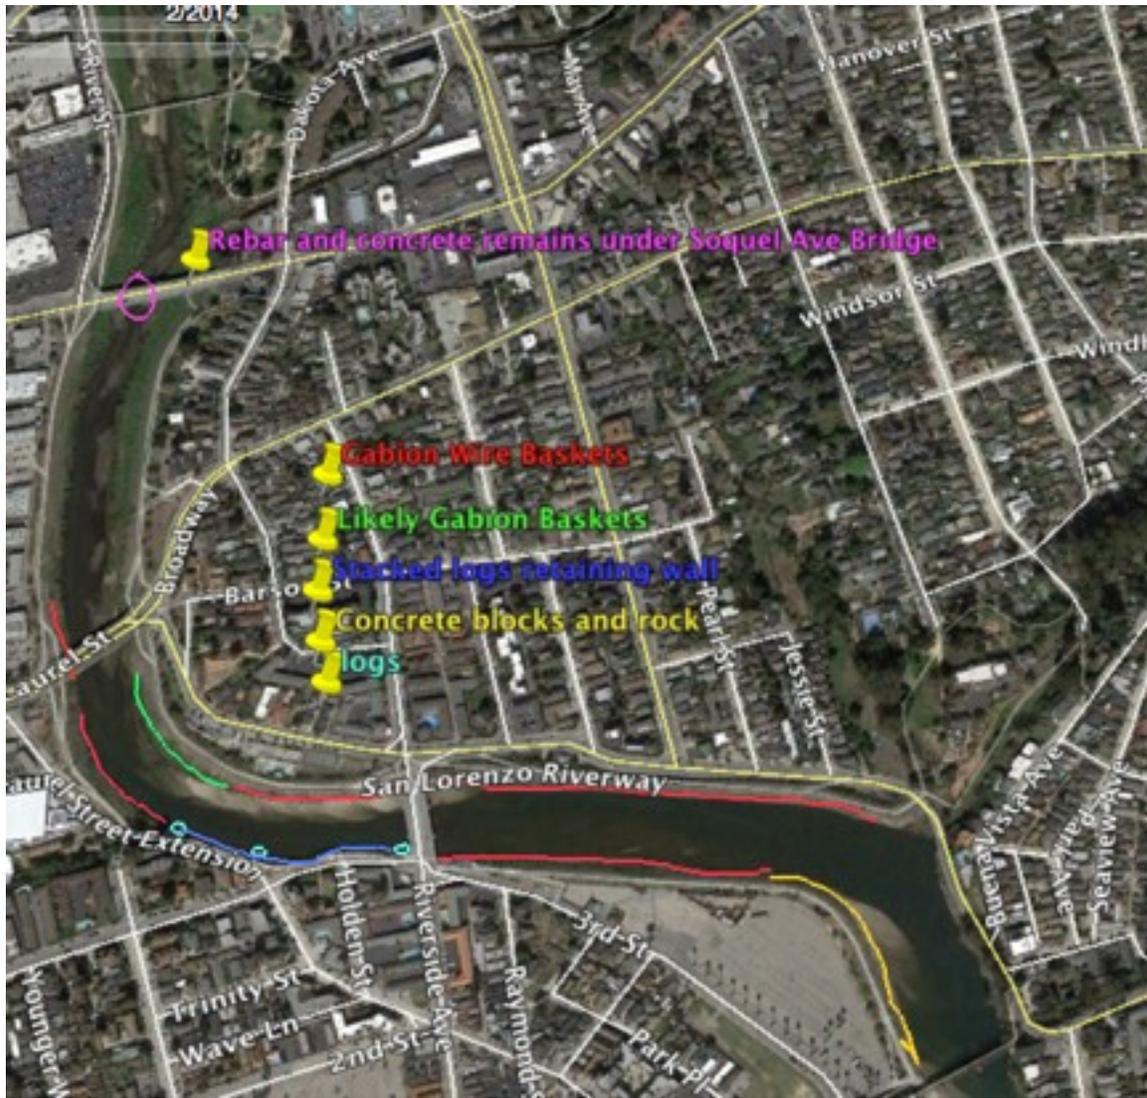
Google Map Showing Location of Hazards on the San Lorenzo River

- 1). Rebar and concrete remains under Soquel Ave. Bridge
- 2). Gabion Wire Baskets
- 3). Evidence of Gabion Baskets
- 4). Retaining wall of stacked logs, rebar and cable.
- 5). Concrete blocks and rock
- 6). Anchored logs just under water surface, placed for fish habitat.

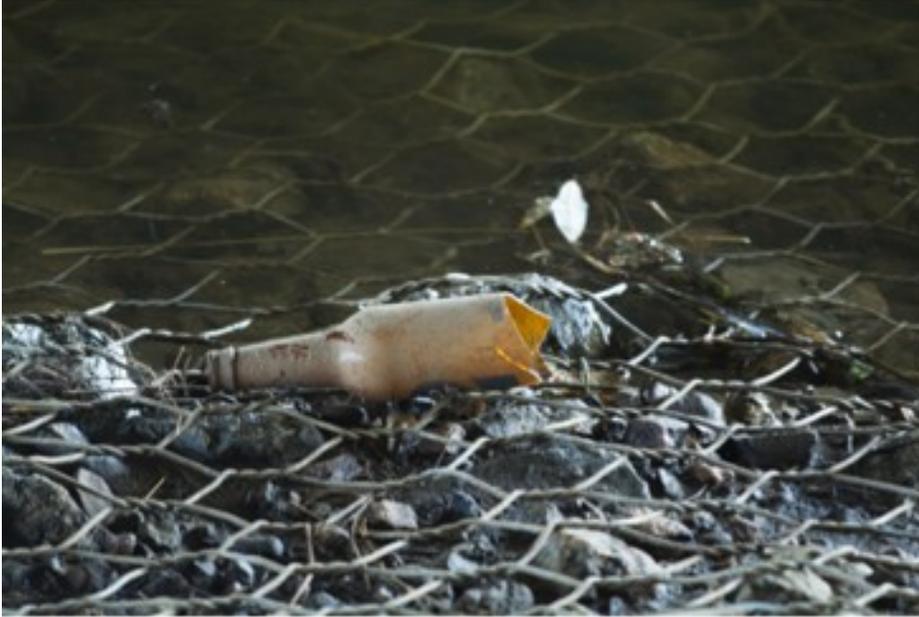
Hazard #6 Unknown risks to paddlers from stepping on debris

Broken glass, used syringe needles, ceramic pieces, metal and other trash can be found in the SLR channel and banks. When getting on or off paddle boards or kayaks, it is customary to do so by walking into the water several feet before getting on.

The river bottom is not dredged, and there is no system in place to clean or monitor what hazards might be under the water or along the banks week-to-week, month-to-month or year-to-year. **Stepping on sharp obstacles along the banks or buried under the sand would pose a risk to paddlers even if they are wearing booties.**

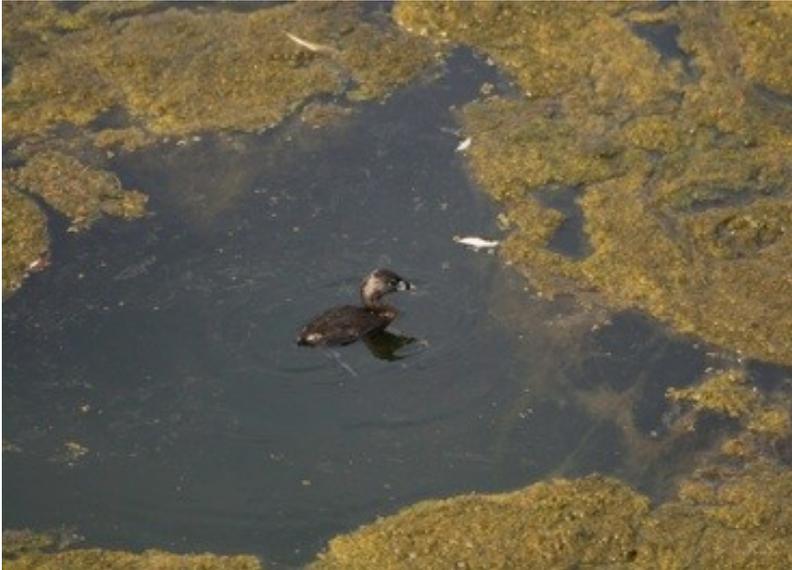
Blue-Green Algae Bloom Aug 30, 2015

An algae bloom photo below from Aug 30, 2015 on the SLR, covers water and shows the limited visibility below the water surface. The lack of visibility of what is below the surface creates a secondary problem, as well as algae having a risk of Blue-Green algae producing toxins.
