Lower San Lorenzo River & Lagoon Management Plan

prepared for: City of Santa Cruz Redevelopment Agency

January 14, 2002

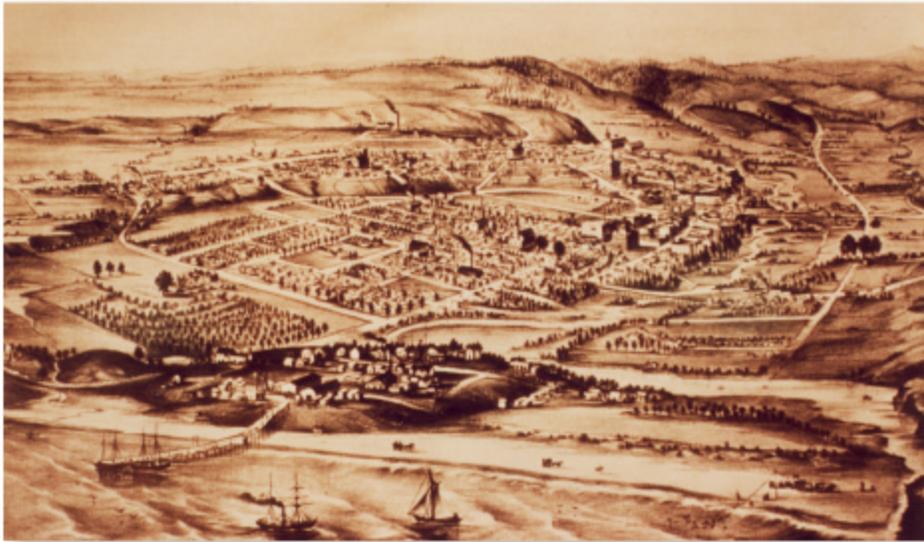
Figure 1: Santa Cruz, California circa 1850.

Like a majority of rivers throughout California, the San Lorenzo River has experienced remarkable changes since European settlement beginning in the early 1800's (Figure 1). The early history of European-style land use involved the establishment of the City and the gradual encroachment on the active channel area with fill and structures beginning in the 1840s. Early maps show that the width of original riverbed and flood plain extended from the present site of the Post Office on Front Street across to the site of the Santa Cruz County Government Center. An 1853 map of Santa Cruz shows a mosaic of active riverbed, forested floodplain, marsh and intertidal mudflat (Figure 2). The entire area now known as the City of Santa Cruz is located in the historic floodplain shaped by the River over tens of thousands of years.

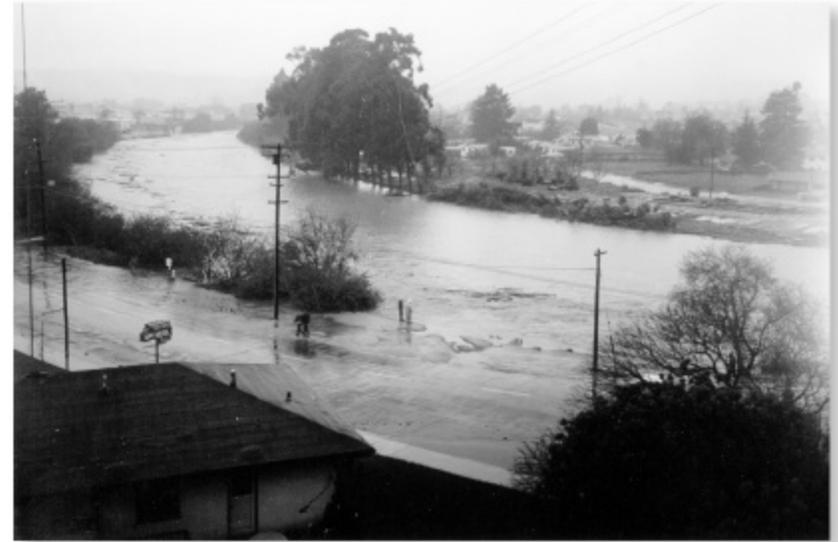
Figure 3: The San Lorenzo River flooding Santa Cruz in 1955.

Urban development from the late 1800s to 1955 involved additional filling and development, which further narrowed the riverbed. Severe flooding in 1938, 1941 and 1955 caused damage to many properties (Figure 3). The 1955 flood prompted the City to implement a U.S. Army Corps of Engineers (Corps) flood control project utilizing levees. The project included construction of levees (completed in 1960), straightening and dredging the river channel and elimination of the riparian corridor (Figure 4). The lagoon and estuary were narrowed considerably by the levee project and a large island was eliminated. A 1968 photo taken near the Santa Cruz County Building shows an absolutely clear riverbed with a flat braided channel (Figure 5).

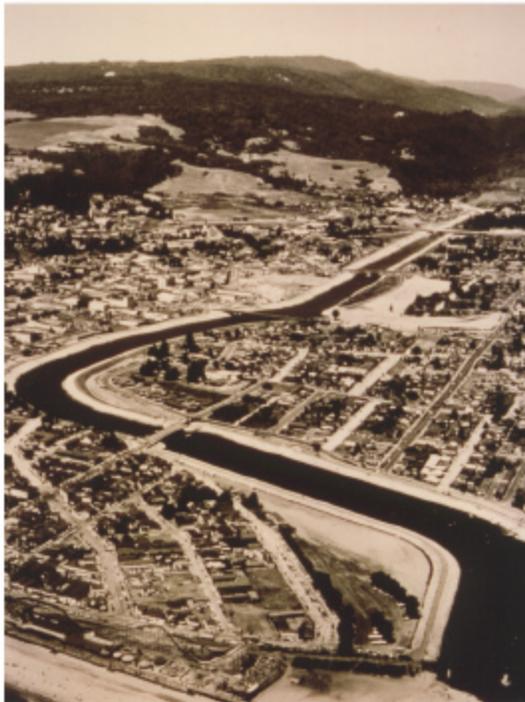
Figure 4: San Lorenzo River following the 1958 levee project.

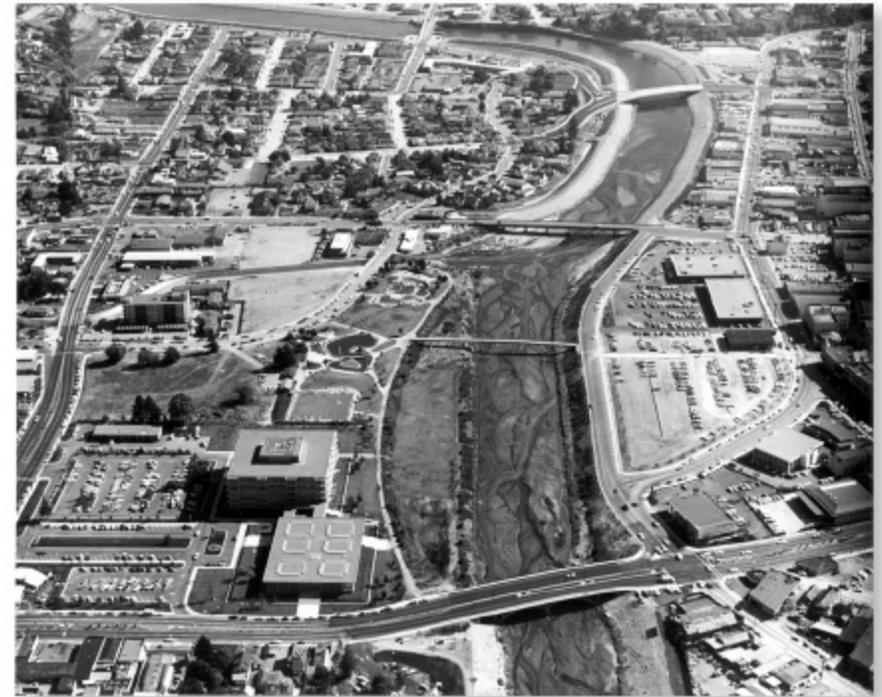
Figure 5: San Lorenzo River in 1968 looking downstream between Water Street and Soquel Avenue. Lack of vegetation and braided channel show the degraded habitat condition.

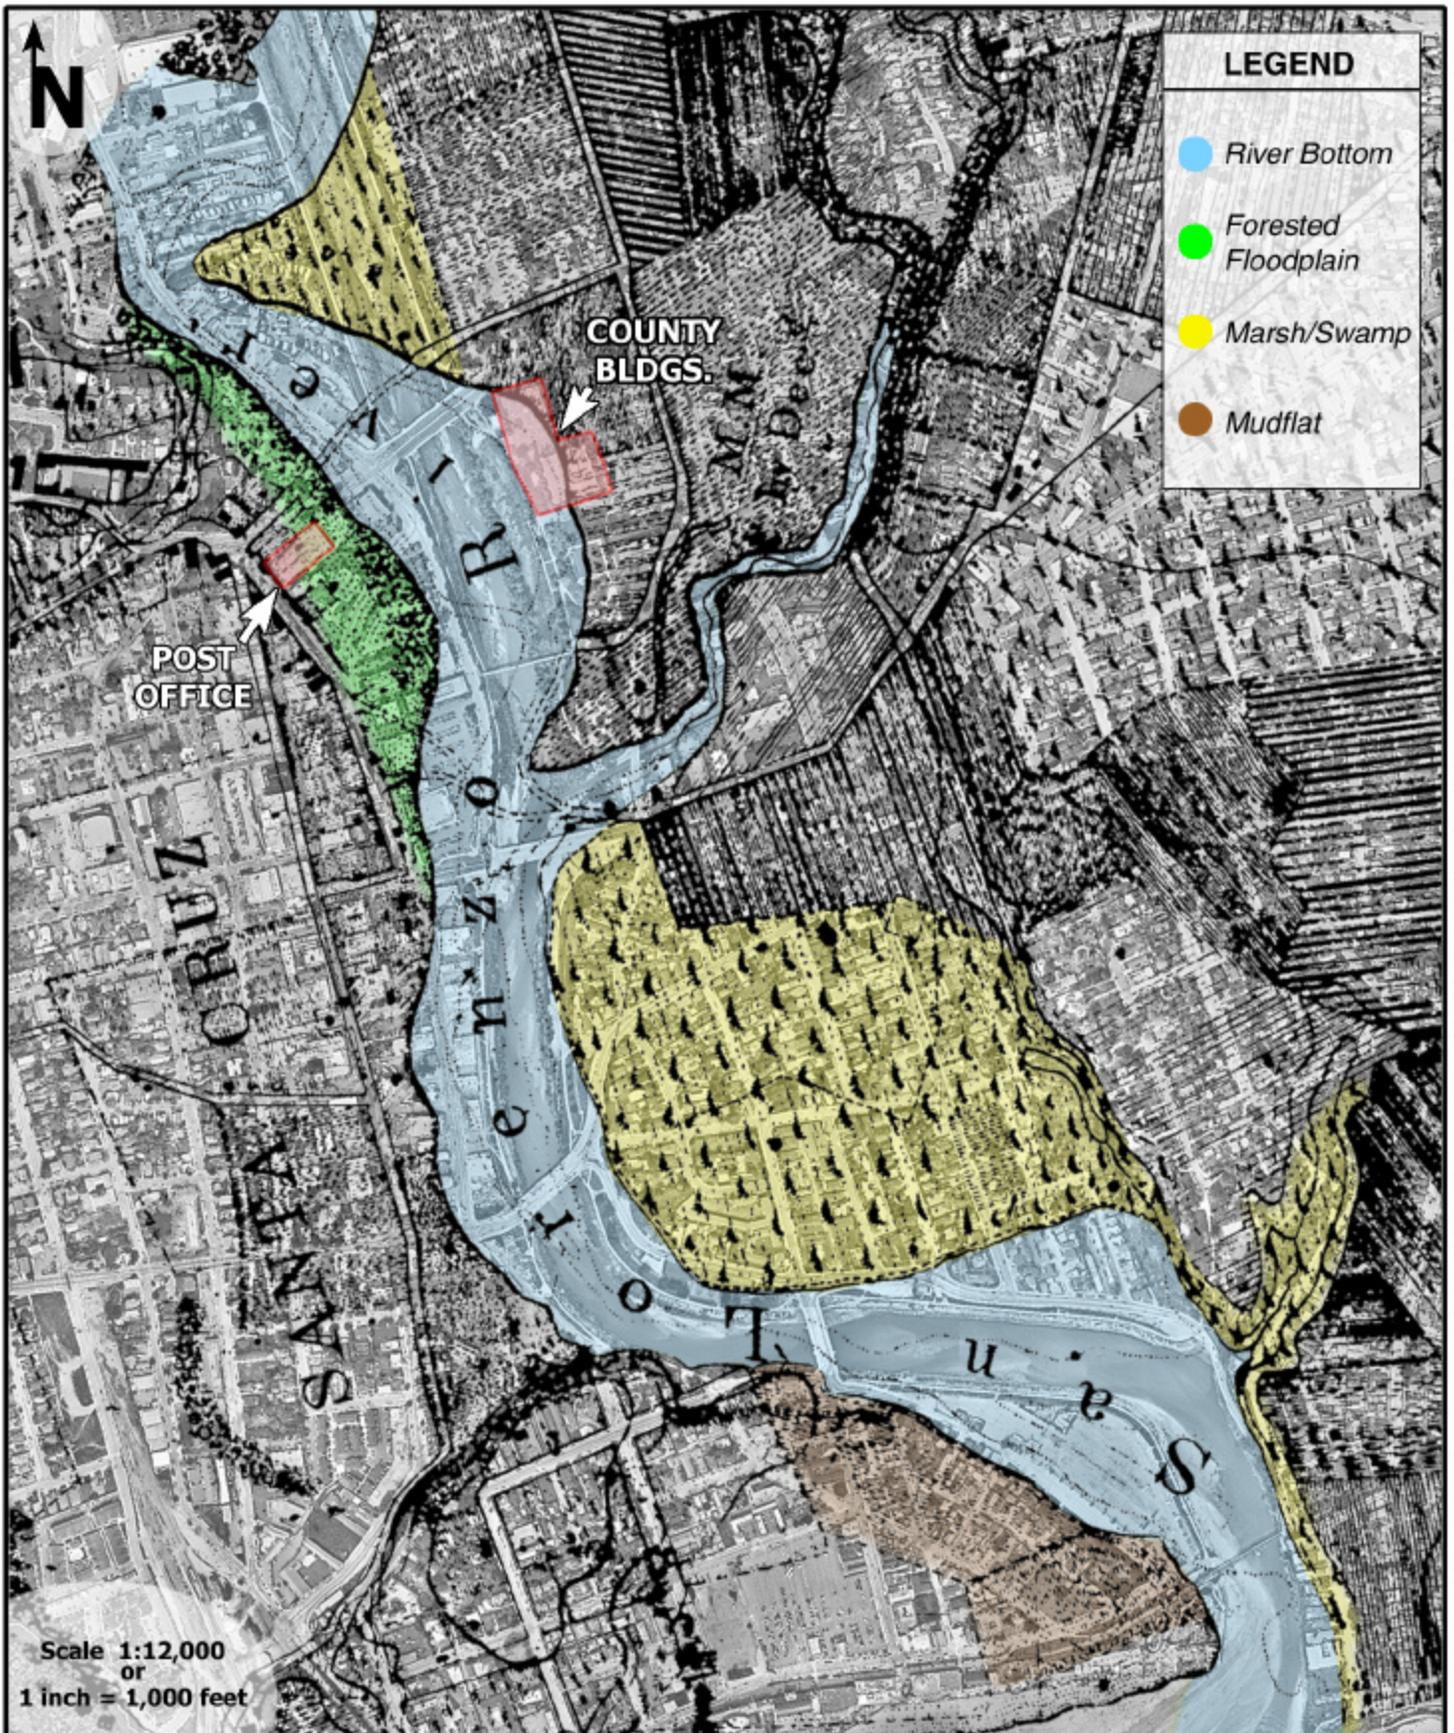
Figure 2: Santa Cruz and the San Lorenzo River as mapped in 1853 superimposed on an orthophoto taken in 1999 show significant changes in land cover. Note the major reduction in areal extent of river bottom and conversion of floodplain areas to commercial, residential, recreational and transportation uses.

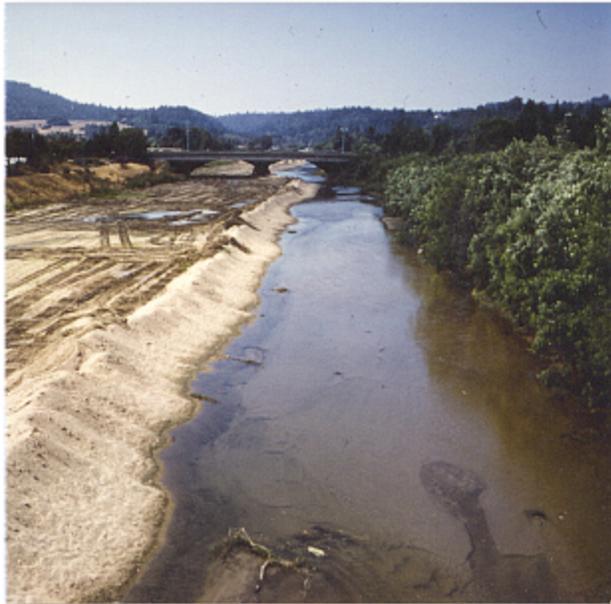
Figure 6: San Lorenzo River looking upstream from Soquel Avenue Bridge circa 1989.

In the 1970s and 1980s, the riverbed was kept clear and a "fish pilot channel" was dredged along the east side of the river (Figure 6 and 7). During this time the Corps of Engineers and the City were embroiled in a dispute over dredging the riverbed of approximately 1.0 million yards of sand that had filled the flood channel. The discord continued until 1982 when the river conveyed more flow than had been calculated due to bed scour during peak flow. This new understanding of scour capacity caused a shift in focus away from dredging and directed new flood control infrastructure efforts to replace flood-constricting bridges and to increase levee heights.

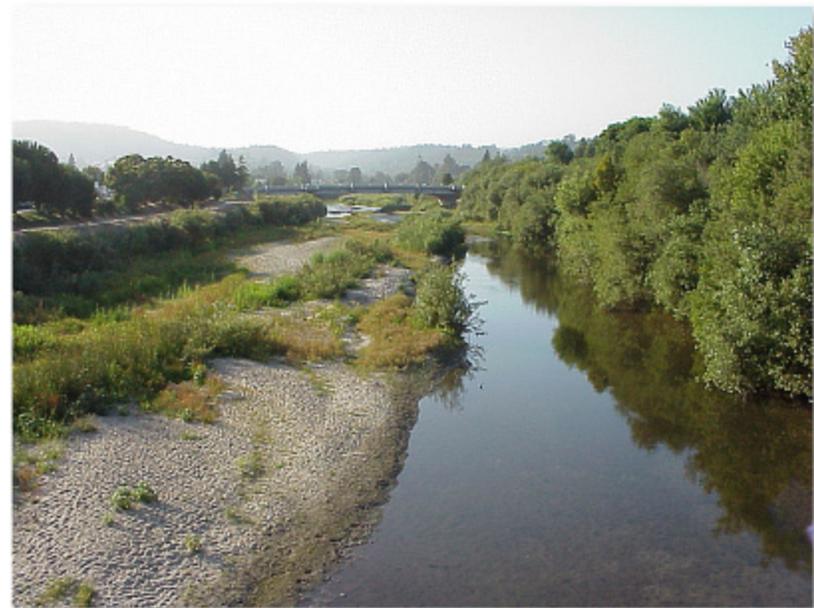
Figure 7: San Lorenzo River looking upstream from Soquel Avenue Bridge in the summer of 1999.

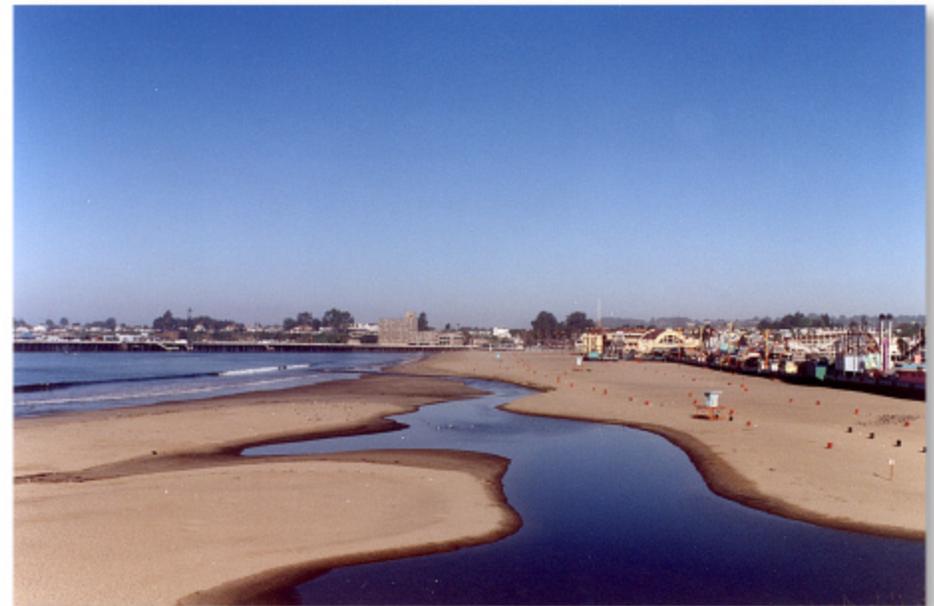
Figure 9: San Lorenzo River mouth in 1998. Channels across the beach are formed naturally by tidal action and scour.

The lagoon management component of the 1989 San Lorenzo River Enhancement Plan called for controlling water levels in the lagoon without sandbar breaching, a practice found harmful to salmonids (Figure 9). Flooding problems occurred regularly during the summer seasons when the sandbar closed and the water level in the river through town increased. Storm drains flooded onto the streets in the lower Ocean Street neighborhood and basements in the downtown area flooded. Research found that low lagoon levels do not necessarily harm habitat conditions, but breaching degrades the water quality of the lagoon by re-introducing saltwater during normally freshwater periods. A water level control structure was proposed, but was determined to be infeasible due to liability concerns. The summer flooding problems were solved by installation of new storm drains and abandonment of basements in downtown buildings after the 1989 Loma Prieta earthquake. The lagoon has remained as a natural system since sandbar breaching was halted in 1995 when regulatory permits expired. The City of Santa Cruz has done no formal management of the lagoon since the expiration of permits due to public safety liability issues and natural resource management concerns.

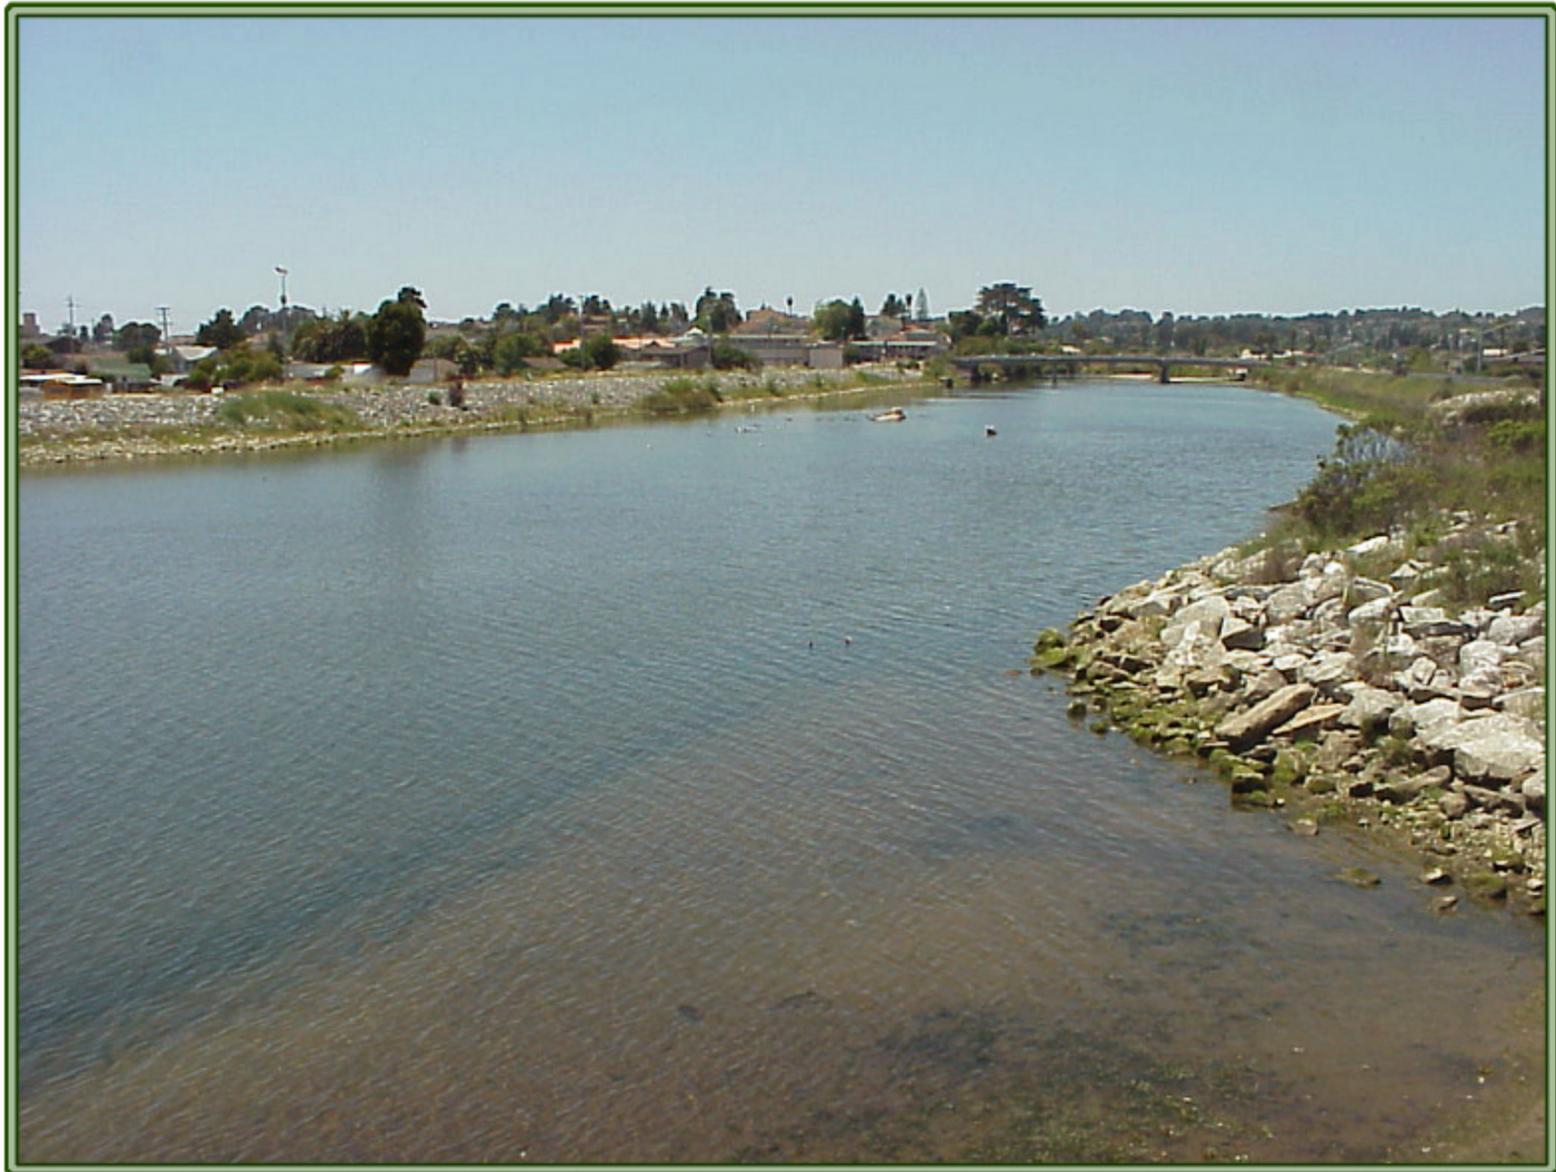
Figure 10: San Lorenzo River Lagoon looking upstream towards the Riverside Avenue bridge in June 2000.

The 1990s era was preceded by the Loma Prieta Earthquake (October 1989), which damaged the Riverside Avenue Bridge beyond repair and initiated its replacement. Between 1994 and 1999 three other bridges, Soquel Avenue, Water Street and Laurel / Broadway, were replaced or modified to improve flood passage and seismic safety. Other changes stemming from the earthquake included filling basements that had flooded in the summer months for seismic stability and completion of the Lower Ocean Street / Barson Street Storm Drain project in 1999. Parts of the levee were damaged and replaced, especially in the lagoon area, and new riprap slopes destroyed what little vegetation had developed. The lagoon remains largely barren in a normally rich ecological zone (Figure 10). The current lagoon habitat quality is probably well below its potential.

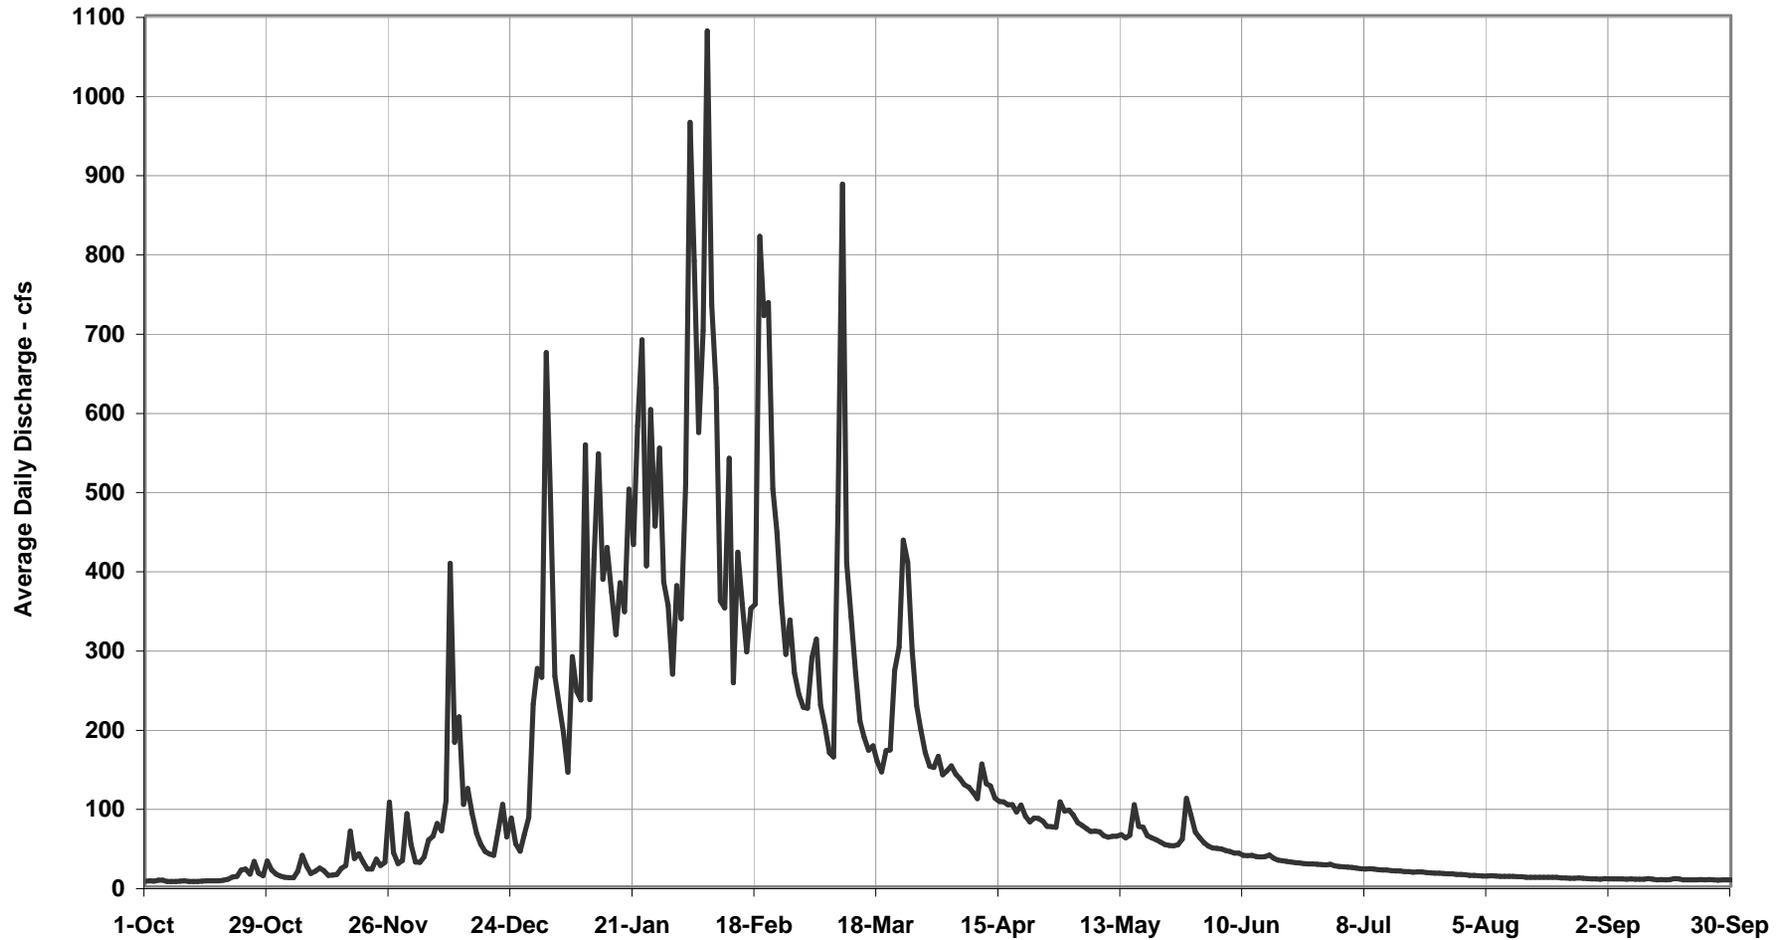
San Lorenzo River at Santa Cruz
Hydrograph of Average Daily Flows (1988-1999)

Figure 11: Hydrograph for the San Lorenzo River at Santa Cruz (USGS gage #11161000) showing the average daily flow in cubic feet per second (cfs) for the period of record from 1988-1999. Typical daily average flows for the dry season range from 6-10 cfs with most precipitation and runoff occurring between early December and late March.

flows in the Lower River have progressively declined over the years. USGS gauges indicate 1977 flows (the lowest rainfall year in recorded history) at the San Lorenzo River gauge at Felton were no lower than 1988 flows (categorized as only a below-average rainfall year). Currently, efforts are made by the City to maintain reasonable bypasses to the Lower River at Tait Street. This unwritten policy has been helped by above average winters in the mid and late-1990's that have kept baseflows relatively high. The City of Santa Cruz Water Department is required to provide bypass flows at Loch Lomond and the Felton Diversion but not at Tait Street. It would be difficult for the City to maintain bypass flows in years of drought as demand for residential water supplies increase in late summer. Moreover, with modest system growth through 2020, unless current supplies are augmented, the City will be unable to meet average annual demands in normal rainfall years. The City of Santa Cruz Water Department recognizes that existing water supplies are inadequate to meet the health and safety needs of its current users in drought conditions.

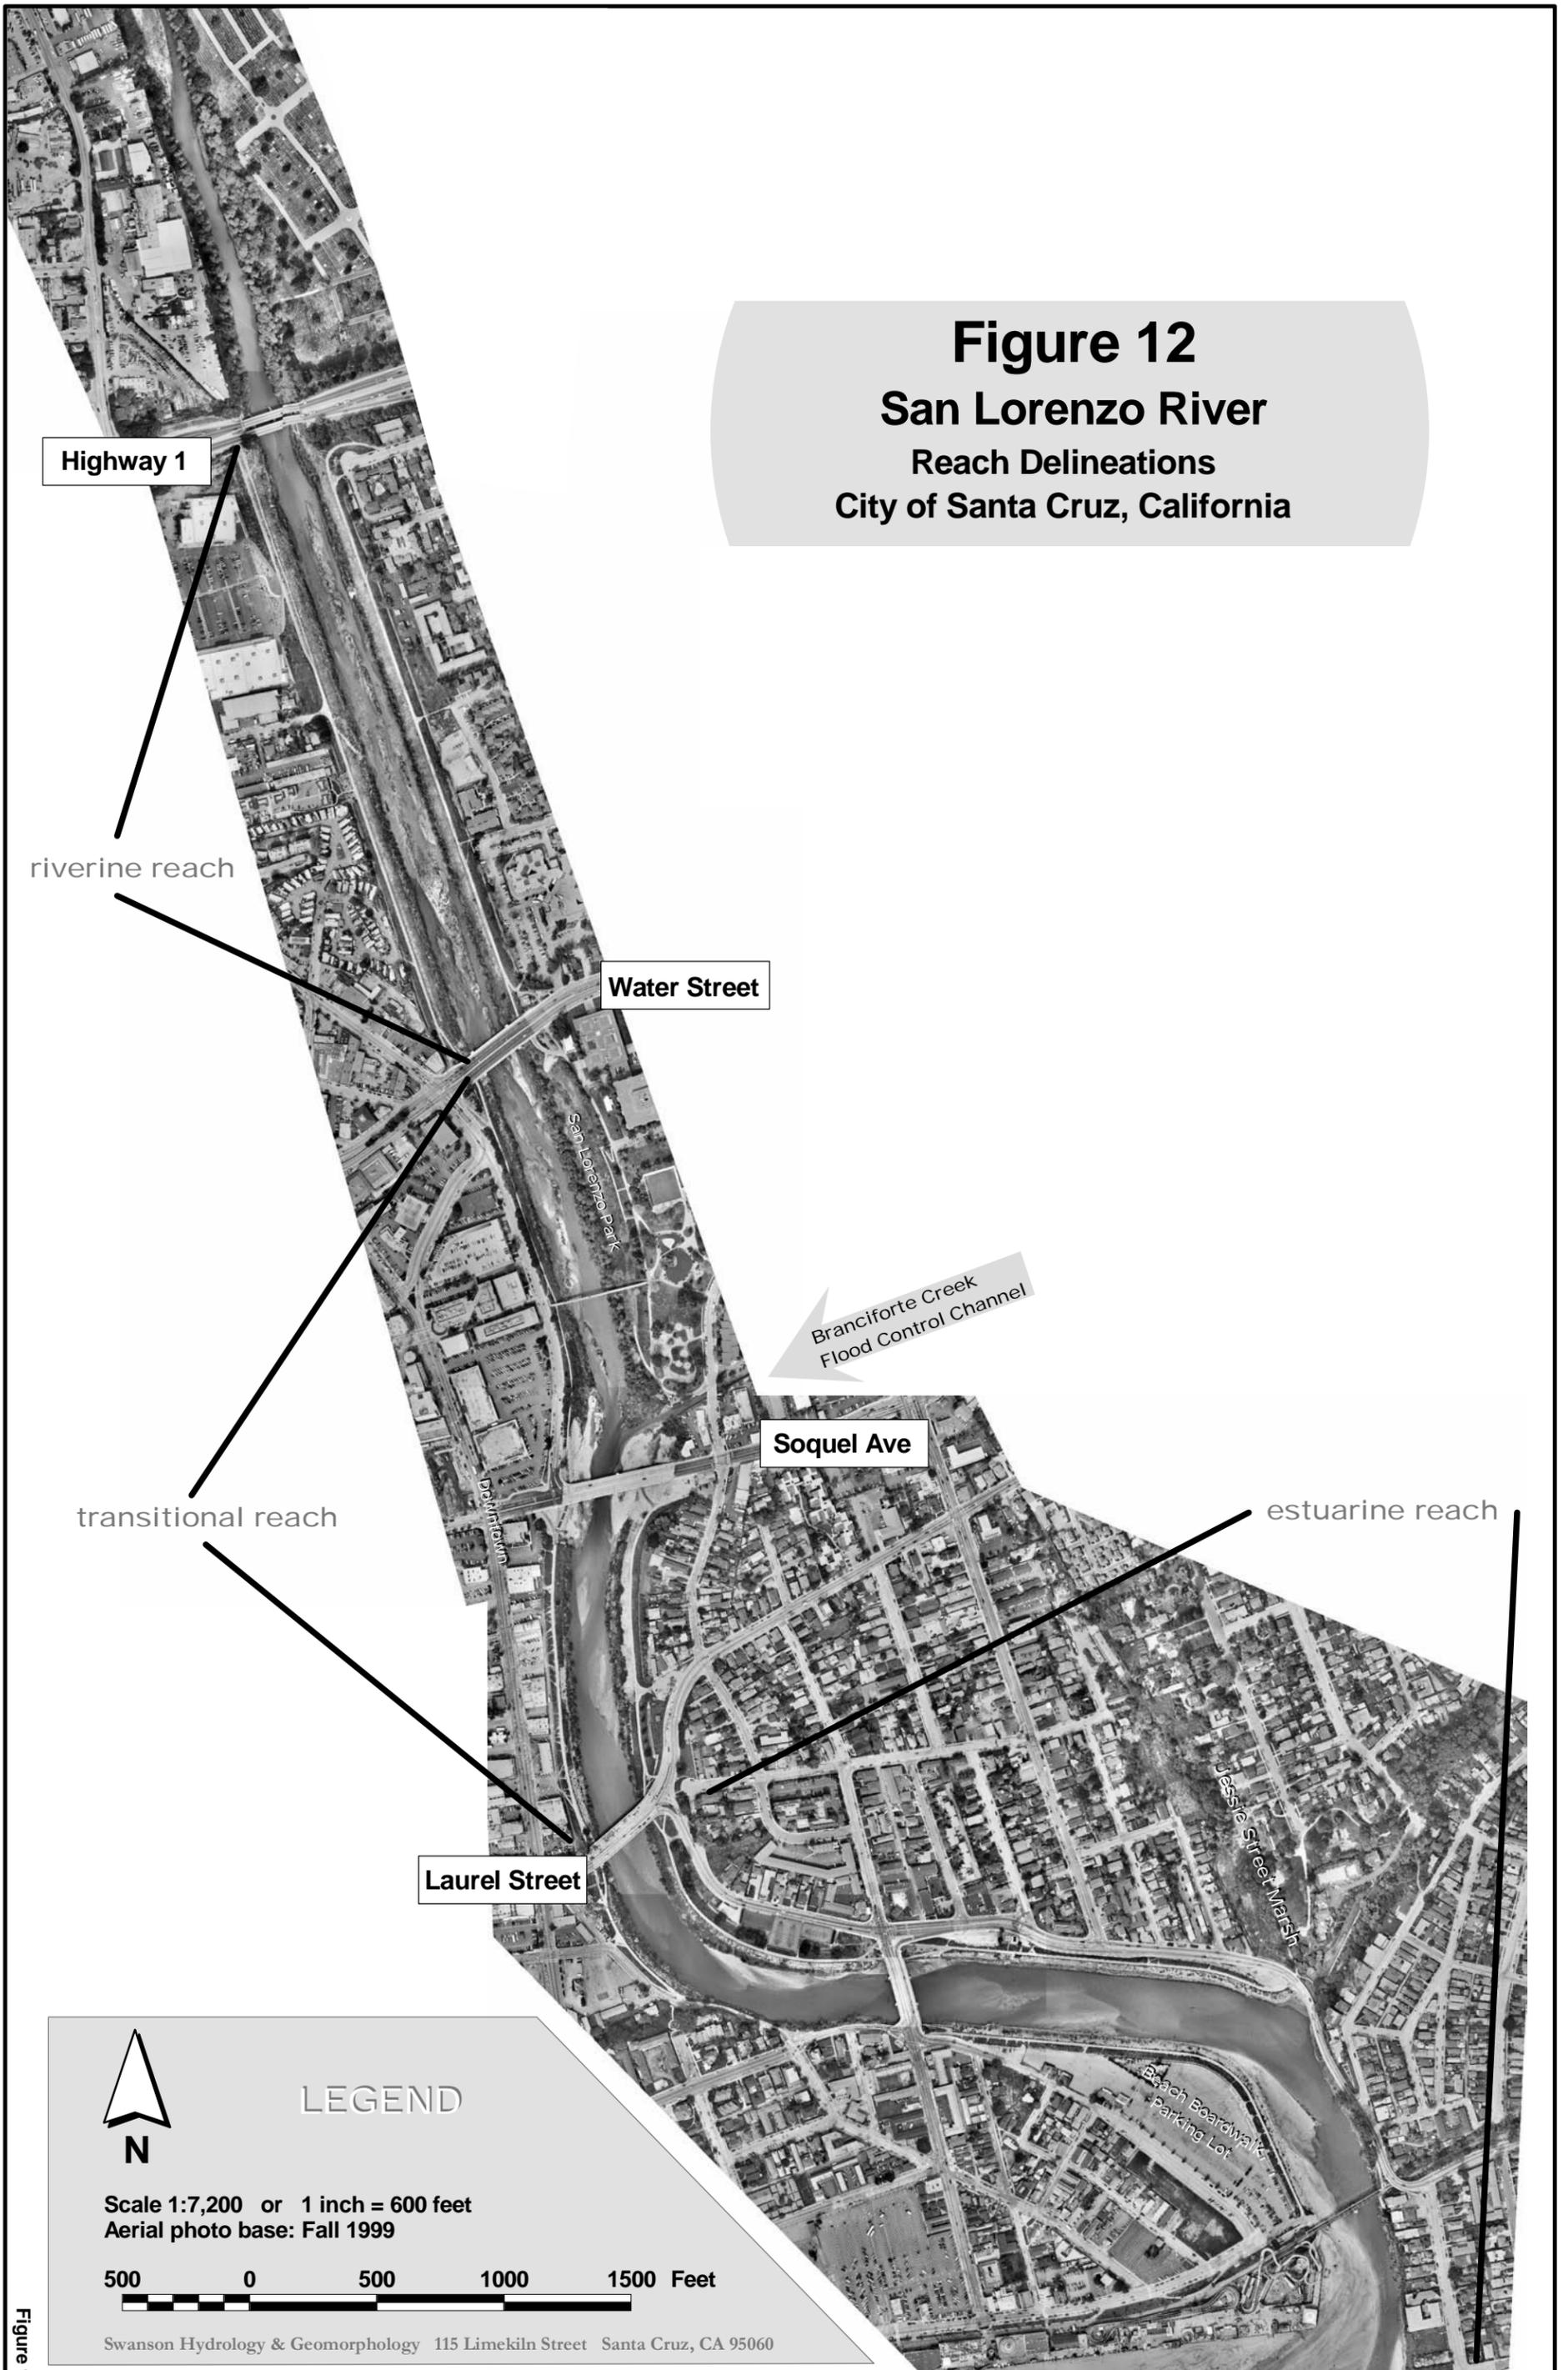
Figure 12
San Lorenzo River
 Reach Delineations
 City of Santa Cruz, California

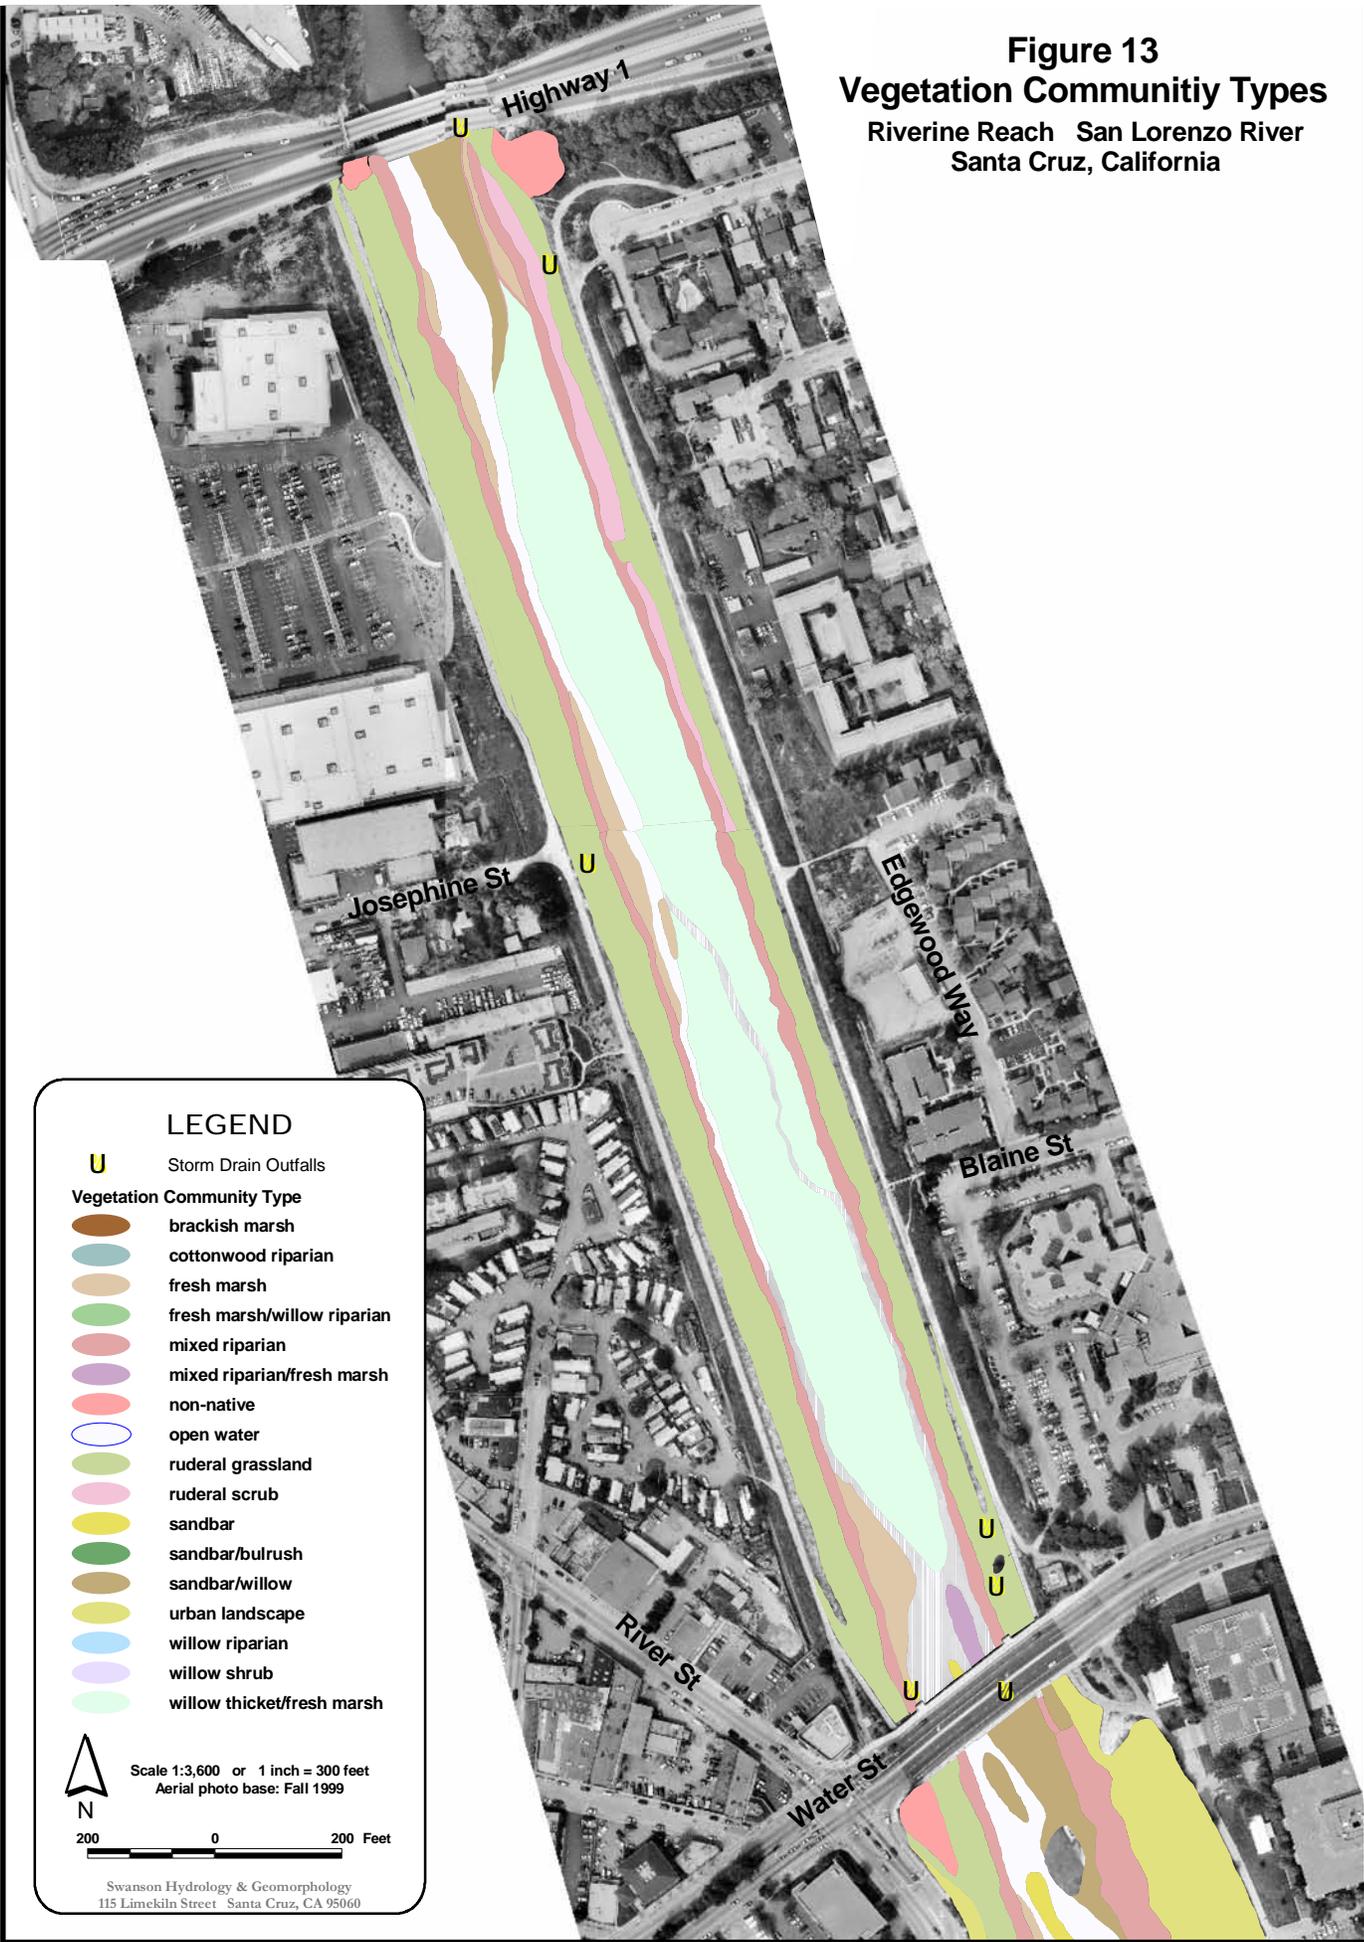
Figure 13
Vegetation Community Types
 Riverine Reach San Lorenzo River
 Santa Cruz, California

The three most prevalent plant communities in the upstream reach are ruderal grassland, mixed riparian forest, and a mosaic of willow thicket and freshwater marsh, which occurs in the channel bottom (Figure 13). Downstream of Highway 1, the open water splits into two channels, which flow past a central “island”.

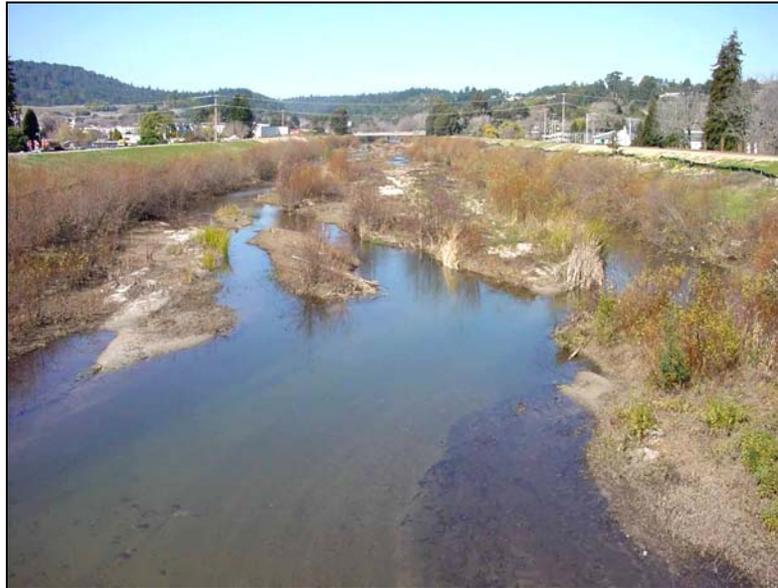
The Riverine Reach looking upstream from Water Street during Winter Conditions

This island is composed of a mosaic of willow thicket and freshwater marsh. Due to the dynamic nature of the channel and periodic scour from high water flows, the island is composed of short-statured vegetation. To a lesser extent, sandbars vegetated with arroyo willow (*Salix lasiolepis*) and species representative of freshwater marsh occur along the channel edges and include cattail (*Typha latifolia*), bulrush (*Scirpus californicus*), matted water primrose (*Ludwegia peploides ssp. peploides*), and water smartweed (*Polygonum amphibium*) (Native Vegetation Network, 2001).

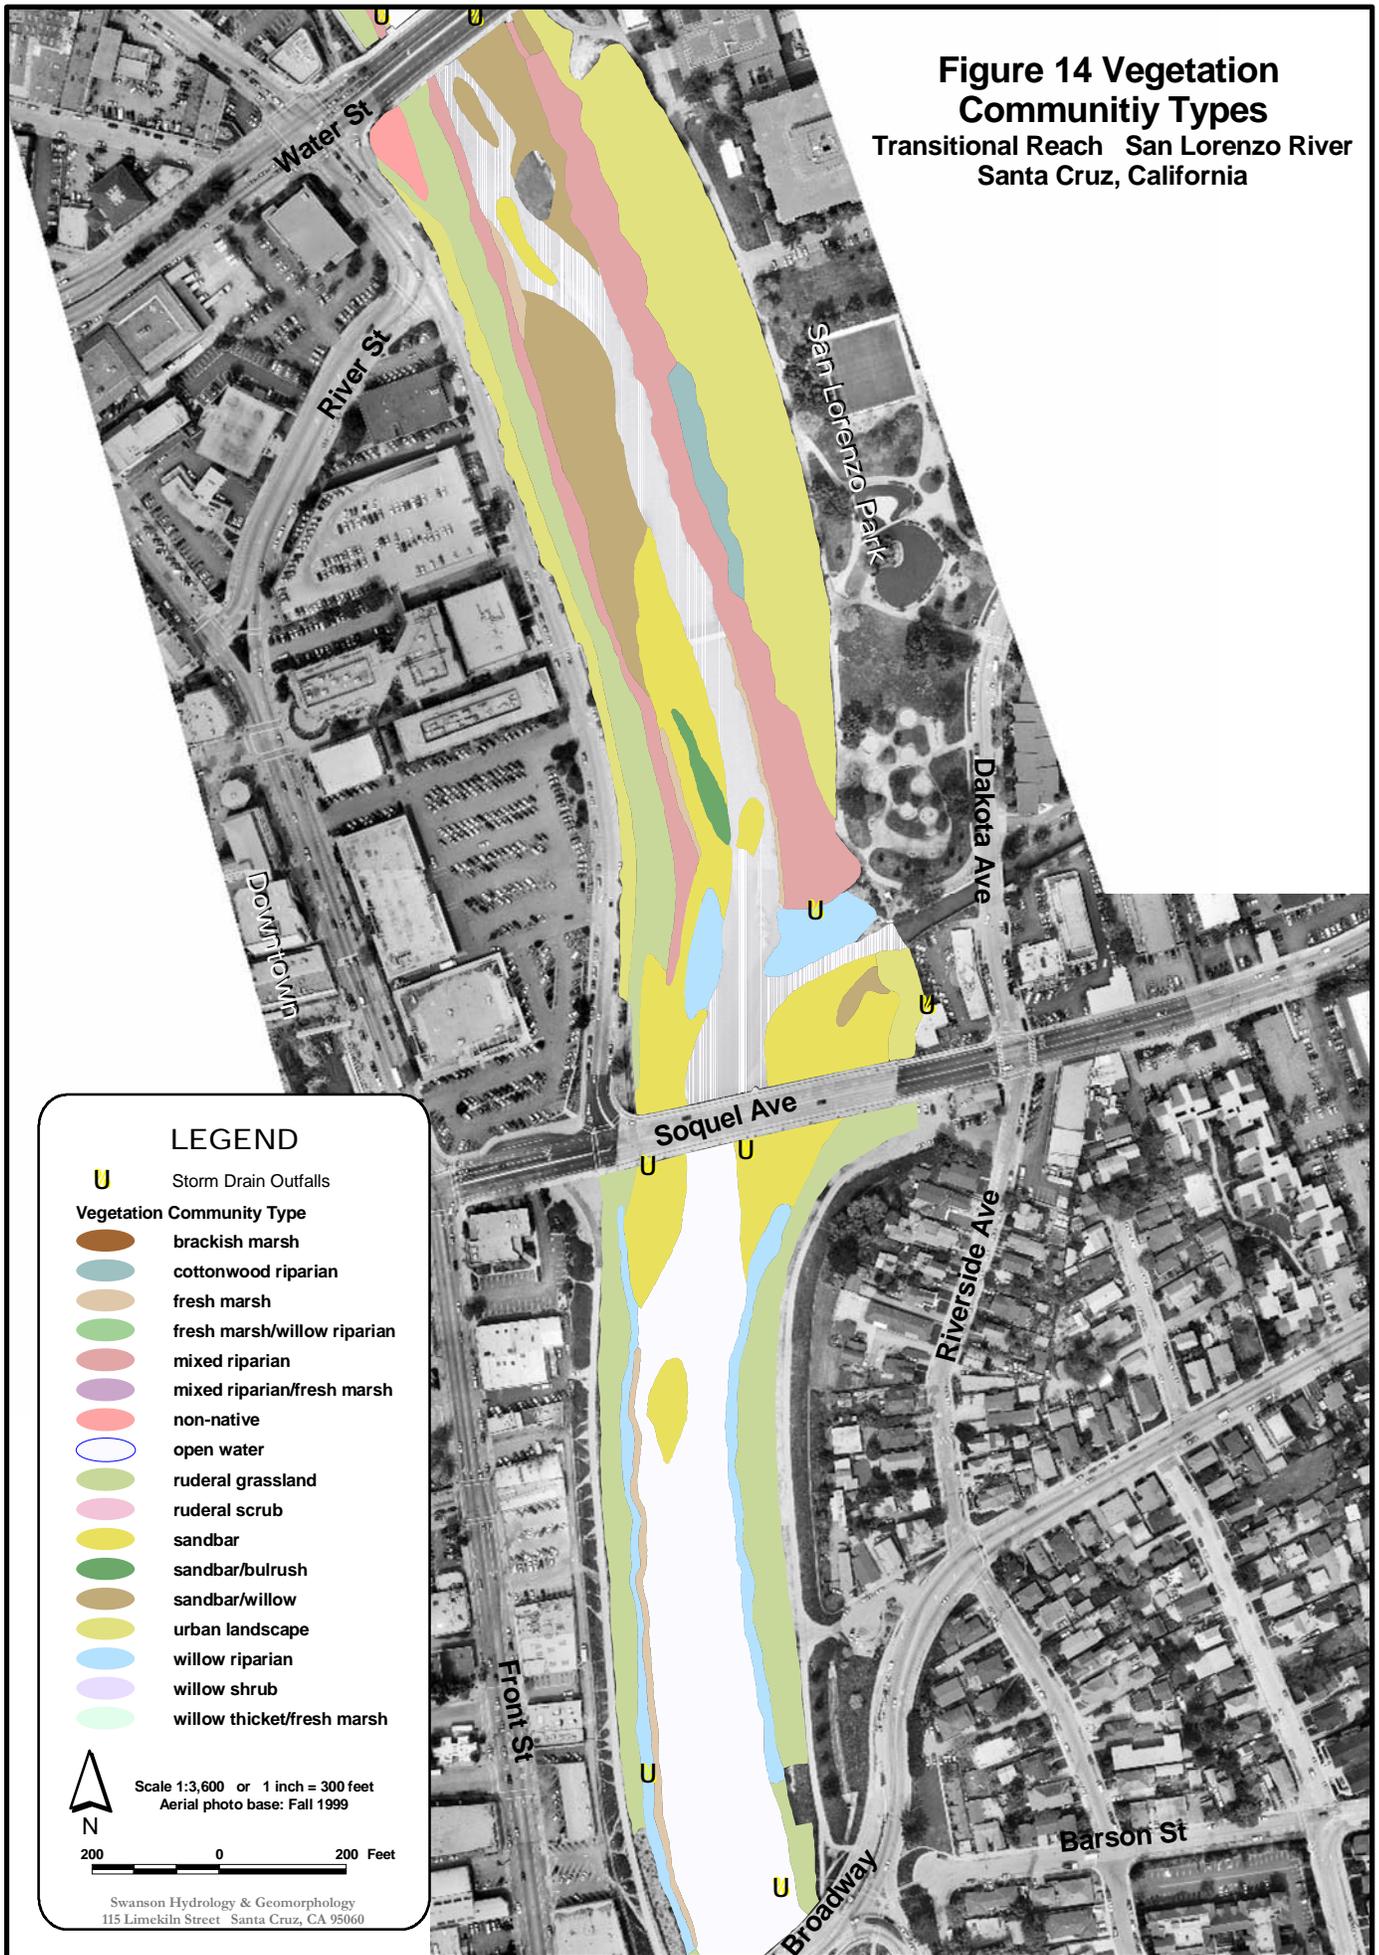
Figure 14 Vegetation Community Types
 Transitional Reach San Lorenzo River
 Santa Cruz, California

The three most prevalent plant communities in the middle reach are urban landscape, ruderal grassland, and mixed riparian forest (Figure 14). The wide east bank and flood plain by San Lorenzo Park supports a more developed stand of mixed riparian forest compared to the upstream reach. Groves of mature black cottonwood trees (60 to 80 feet tall) occur adjacent to the arroyo willow and white alder trees. The willows tend to be distributed at the toe of the bank or channel edge, often in association with small strips of freshwater marsh dominated by bulrush. The urban landscape areas mainly occur at San Lorenzo Park on the east bank and along River Street South on the west bank.

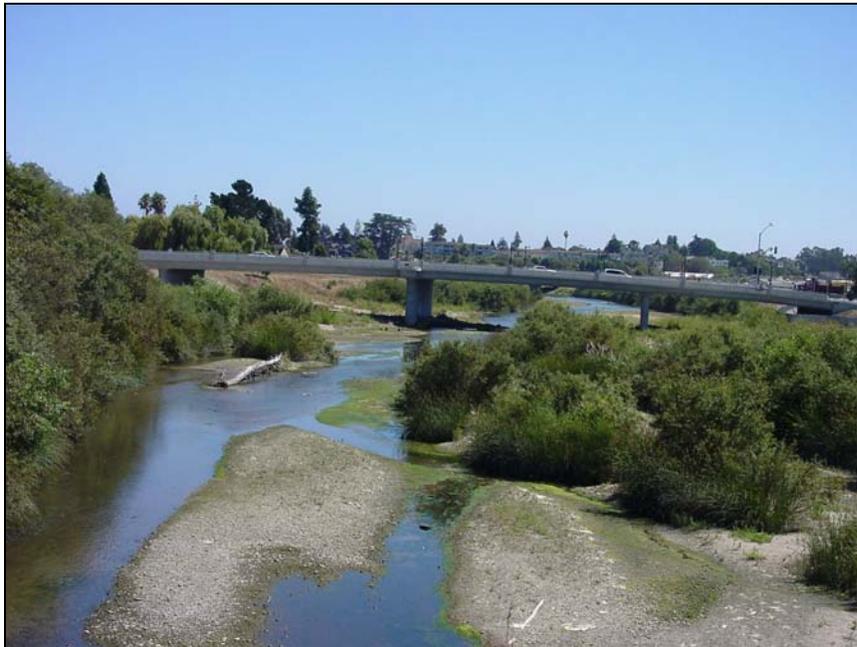
Example of Transitional Reach looking *downstream* from the pedestrian bridge

From a purely geomorphic perspective, this reach functions in a similar way to the riverine system described above. Channel and bar features are formed during winter months when the mouth is open forming a primary bankfull channel with several secondary side channels that only have water during high flow events. The secondary channels will tend to scour during high flow events as flow converges into them and around the stable bar features. This process is evidenced by coarse substrate (gravels and cobbles) found in the secondary channels.

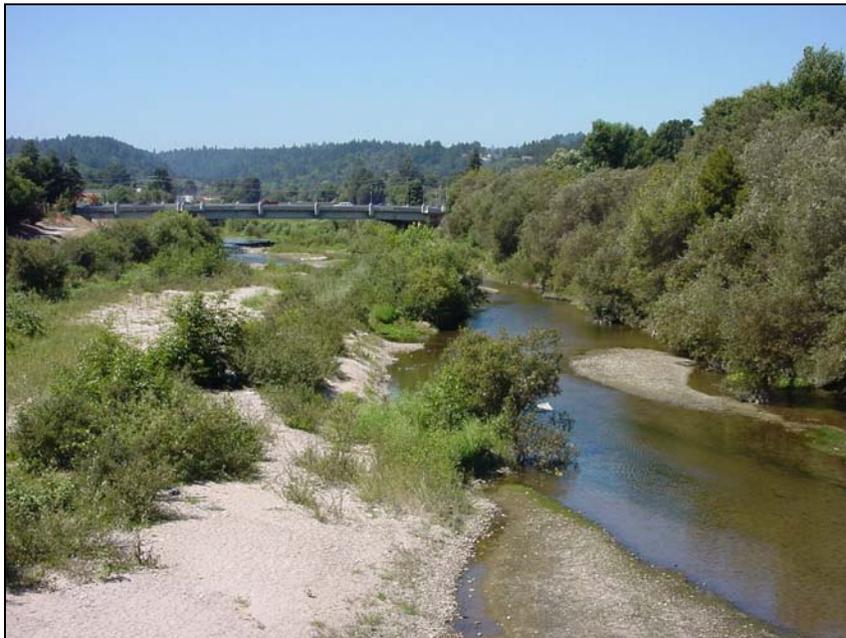
Example of Transitional Reach looking *upstream* from the pedestrian bridge

If scour objects are present in the secondary channels, deep scour holes may form and develop into back channel pools as flows recede.
