Lower San Lorenzo River & Lagoon Management Plan

prepared for: City of Santa Cruz Redevelopment Agency

January 14, 2002

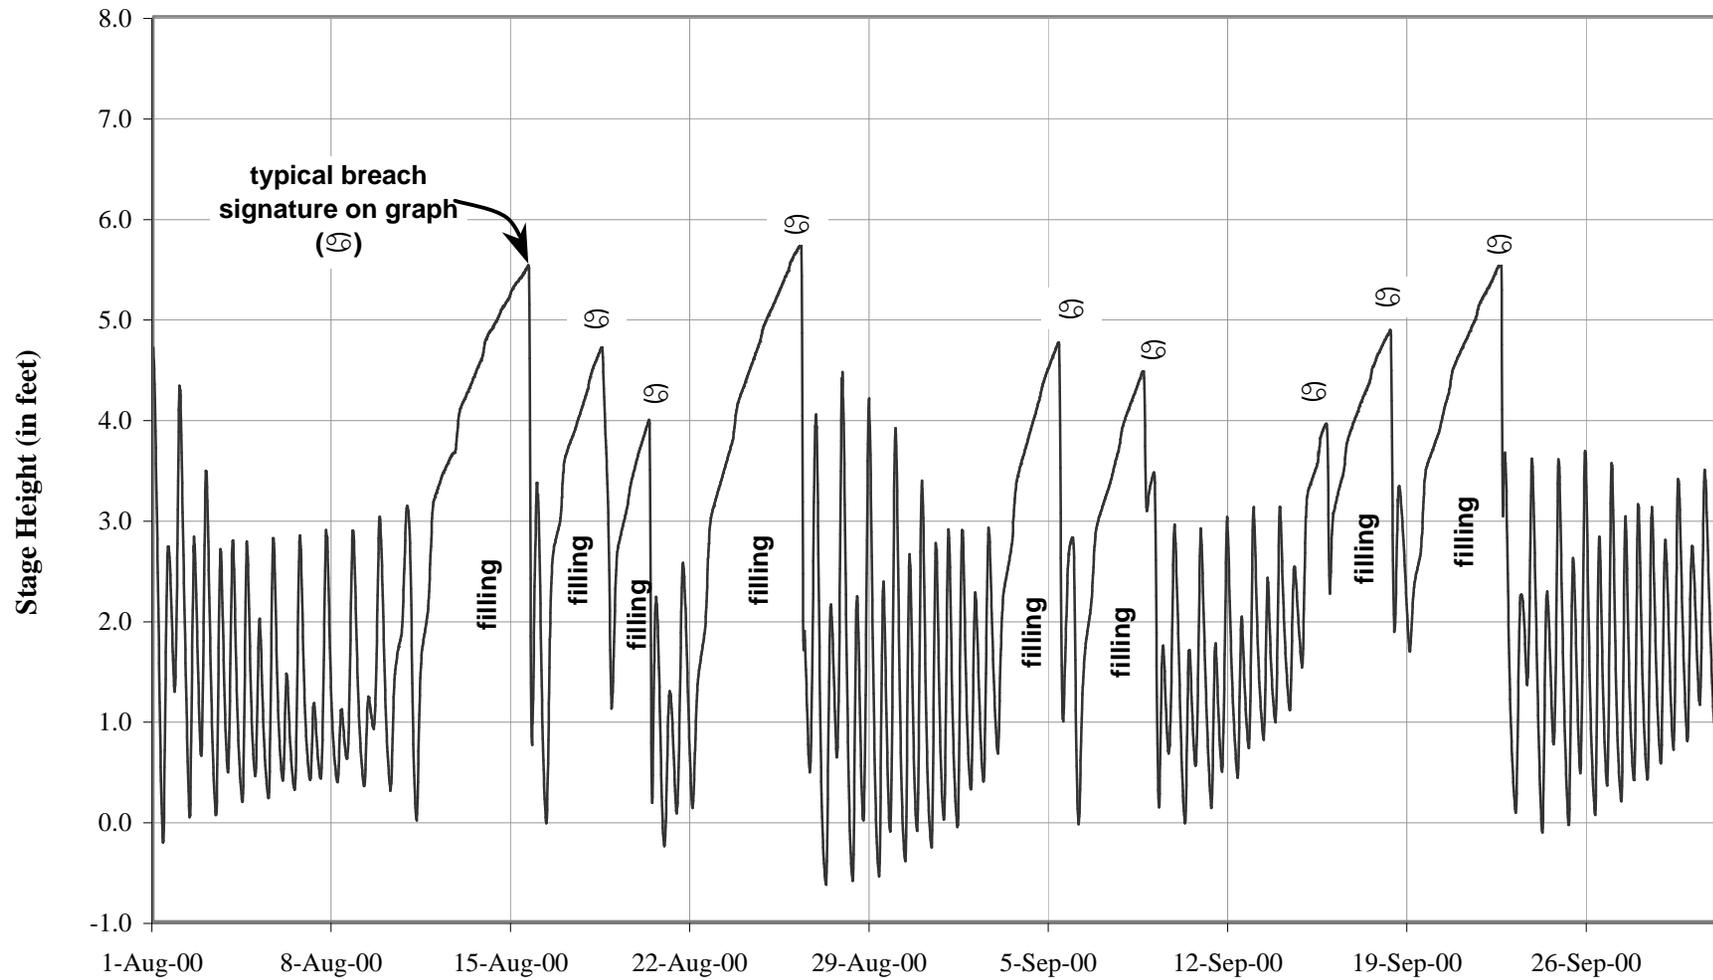
Figure 15: Records of water surface stage on the San Lorenzo River Lagoon at the Jessie Street Marsh outlet through August and September 2000 show a pattern of lagoon filling and breaching. Filling occurs when waves push sand into the mouth of the river forming a barrier to outflow. Breach events (B) break through the beach barrier and reestablish tidal influence in the lagoon. In the absence of mixing, the differing densities between river and sea water creates layering or stratification in the water column. Significant differences between salinity levels at the surface and along the bottom are common.

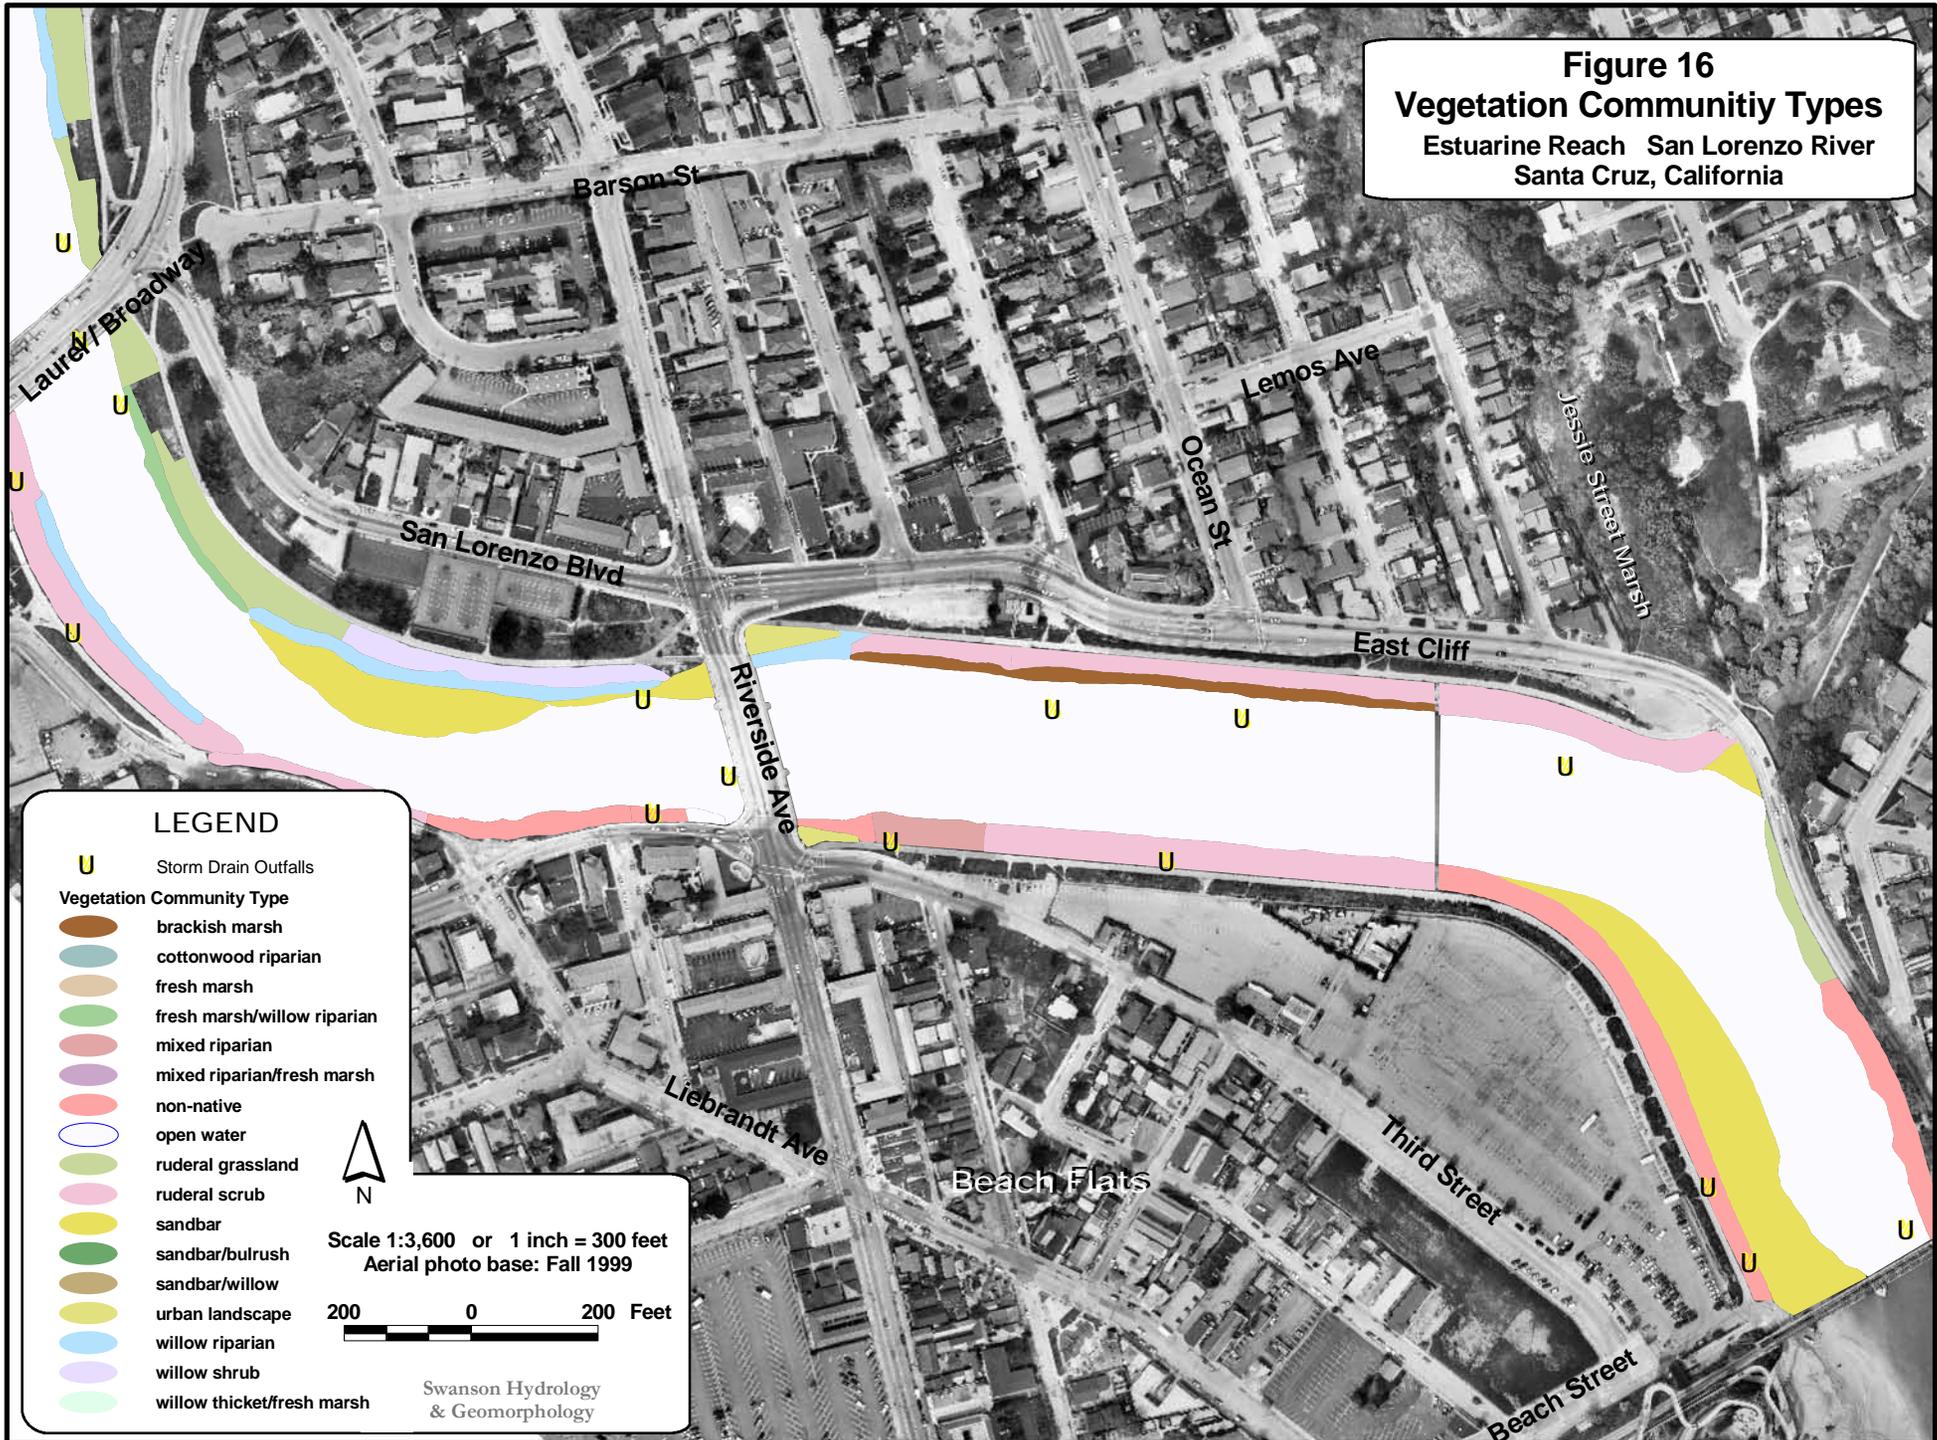
Figure 16
Vegetation Community Types
 Estuarine Reach San Lorenzo River
 Santa Cruz, California

Downstream of the Laurel Street Bridge the riparian forest is dominated by arroyo willow. Fewer white alders and black cottonwoods occur compared to upstream of the Laurel Street Bridge. This may be partially explained by changes in water salinity, as conditions become more brackish downstream. The freshwater marsh is reduced in size, and occurs as a narrow

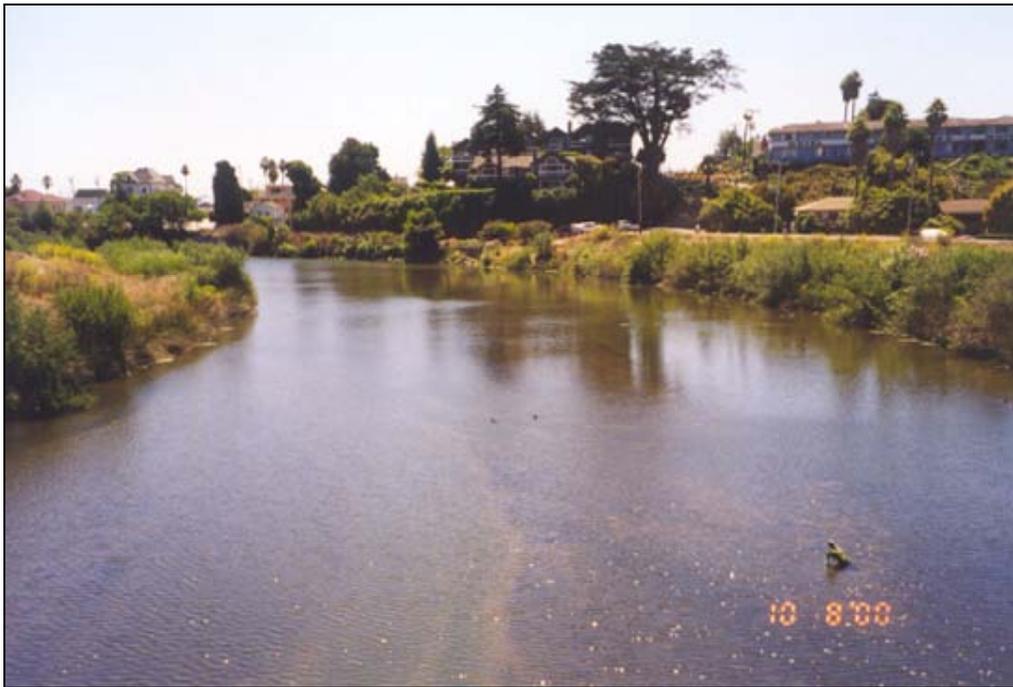
Example of Estuarine Reach looking downstream from vicinity of Laurel Street Bridge

The levees in the downstream reach have been stabilized with riprap, which has resulted in the establishment of weedy and/or opportunistic species. The majority of the vegetation below the Riverside Bridge is composed of non-native species. A large grove of blue gum eucalyptus (*Eucalyptus globulus*) is located on the steep eastern bank by the railroad trestle. The trees are helping to stabilize the steep bank. Upstream of the eucalyptus grove, there is a small area of ruderal grassland, which is dominated by wild oats, pincushion flower

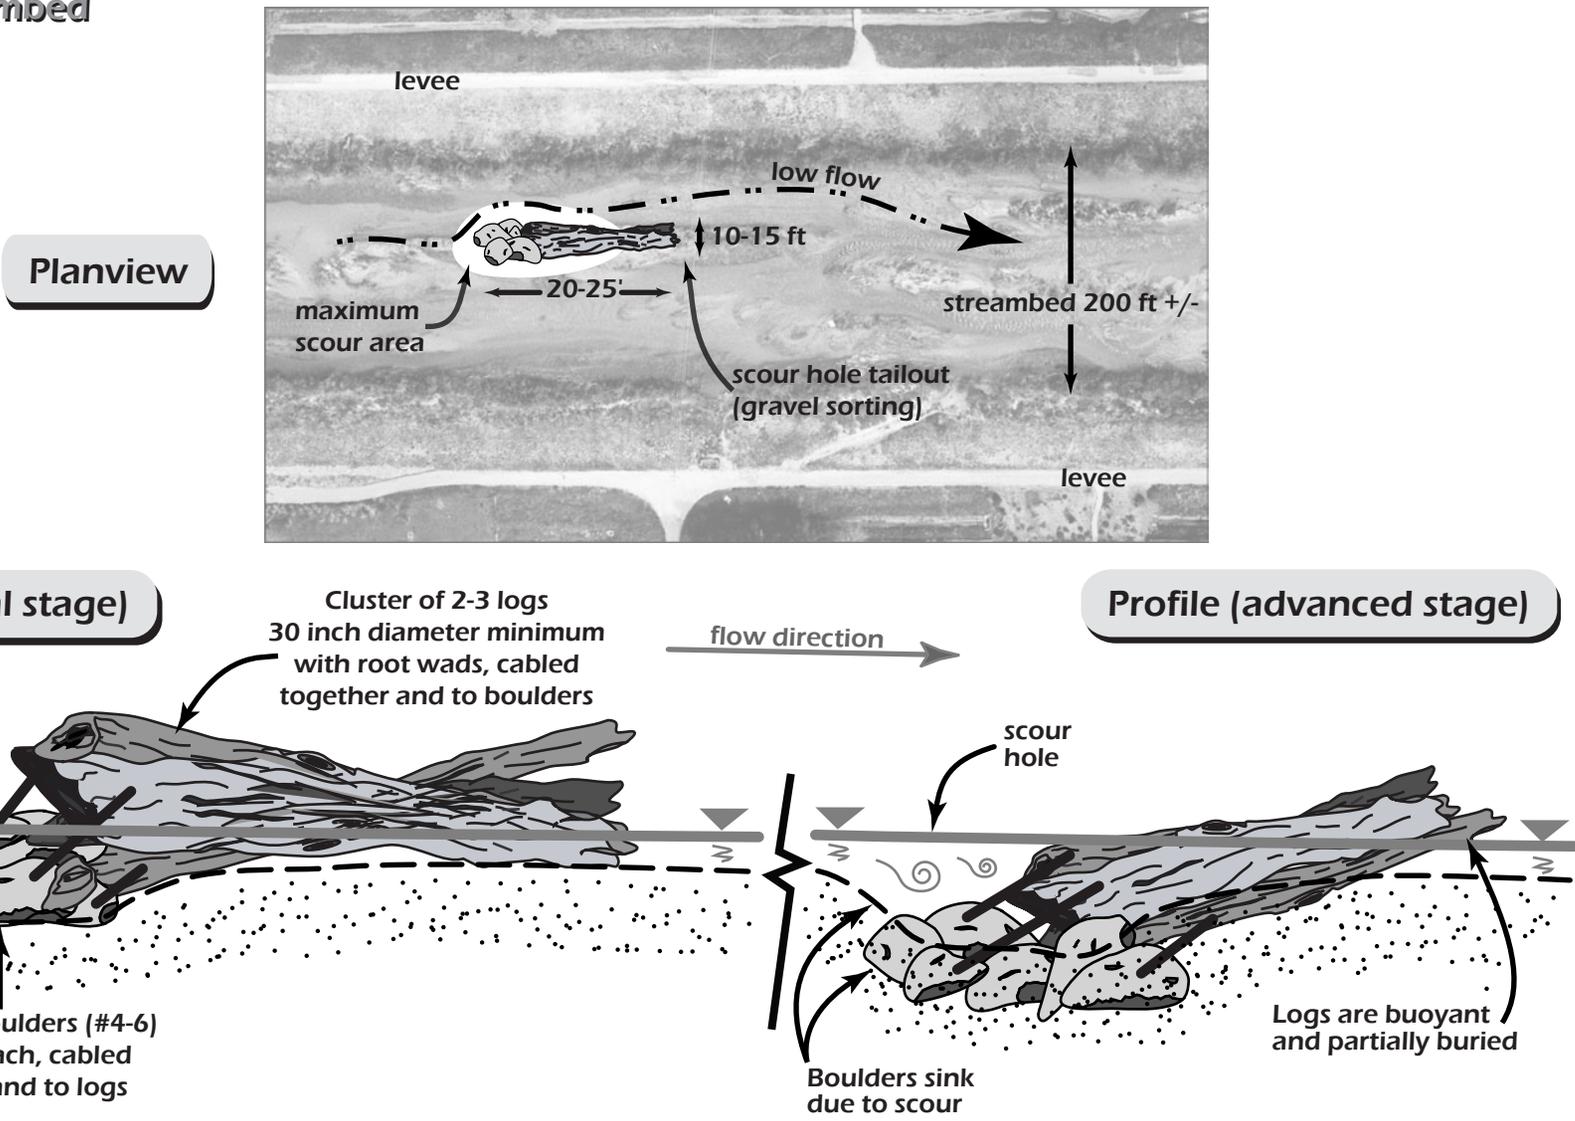
Log / Boulder Large Roughness Objects Placed on Streambed

Figure 17: Plan and profile depictions of log and boulder large roughness objects placed on streambed to induce bed scour and enhance instream habitat.

- **Log / boulder structures** (Figure 17) consist of large logs, in excess of 30 inches in diameter, at least 15 feet long and with root wad attached, cabled to large boulders, in excess of 30 inches mean diameter or 1.5 tons. These are commonly used as naturalistic large roughness objects to promote bed scour for pool formation and to flush sand leaving coarser particles of cobbles and gravels (CDFG, 1998; Rosgen 1993). In the example shown (*see photo*), the hydraulic effect of the log/boulder structure was sufficient to move large cobbles and small boulders leaving a deep 3 + foot hole and wood cover. These structures would be placed along the edge of the low water channel in the upper estuarine and transitional reaches. In the San Lorenzo River, the boulder segments of these structures would likely sink into the sandy bed during flood events, but the log would be buoyant, align in the direction of flow and should persist on the channel bed surface up to 20 years. They could be

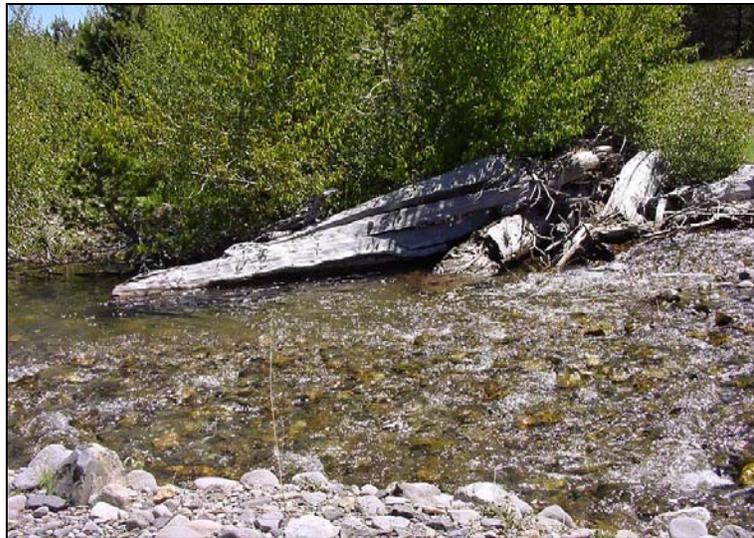
Example of log / boulder habitat enhancement structure for streambed and shoreline enhancement.

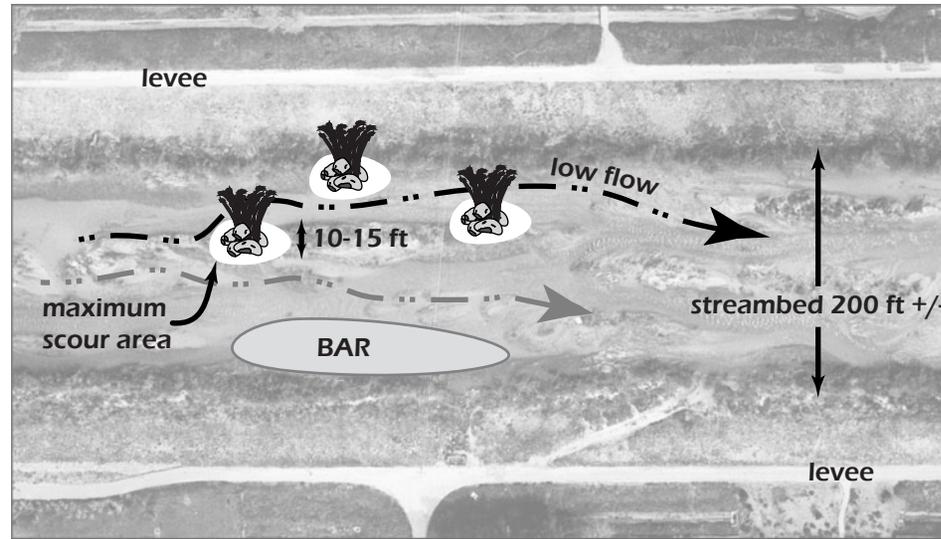
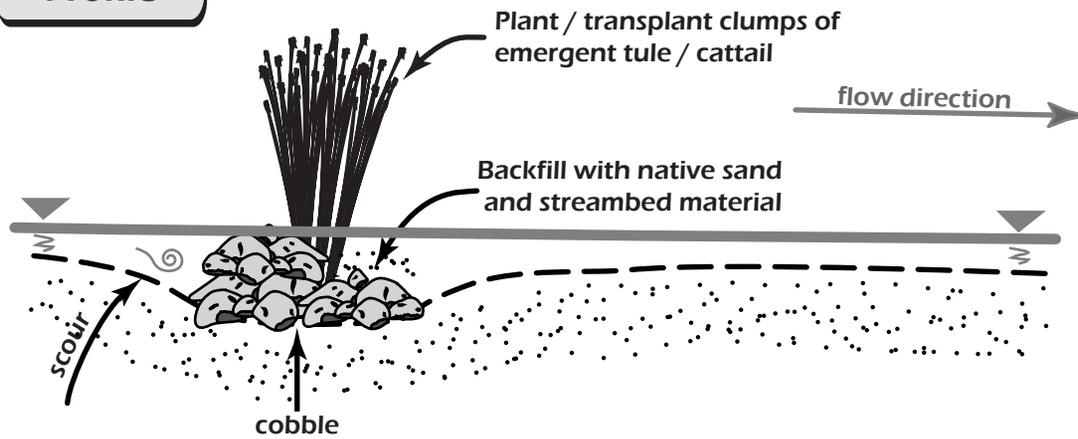
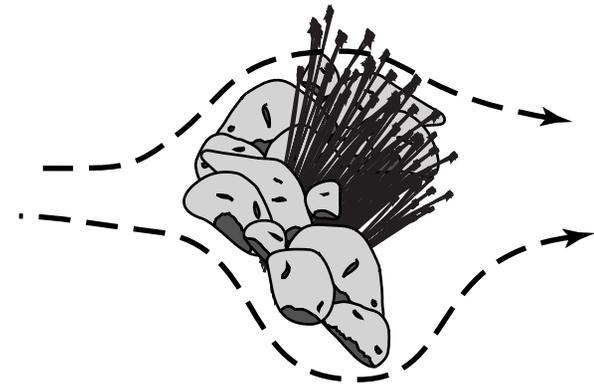
Tule / Cattail Clumps Placed on Streambed

Figure 18: Plan and profile depictions of tule / cattail clumps placed on streambed to induce bed scour and enhance instream habitat.

Figure 18 shows a sketch of the proposed structures. These can be placed directly on the streambed, or at the base of banks that are lacking riparian cover. Plant materials are abundant in the Riverine Reach and could be scavenged for the structures.

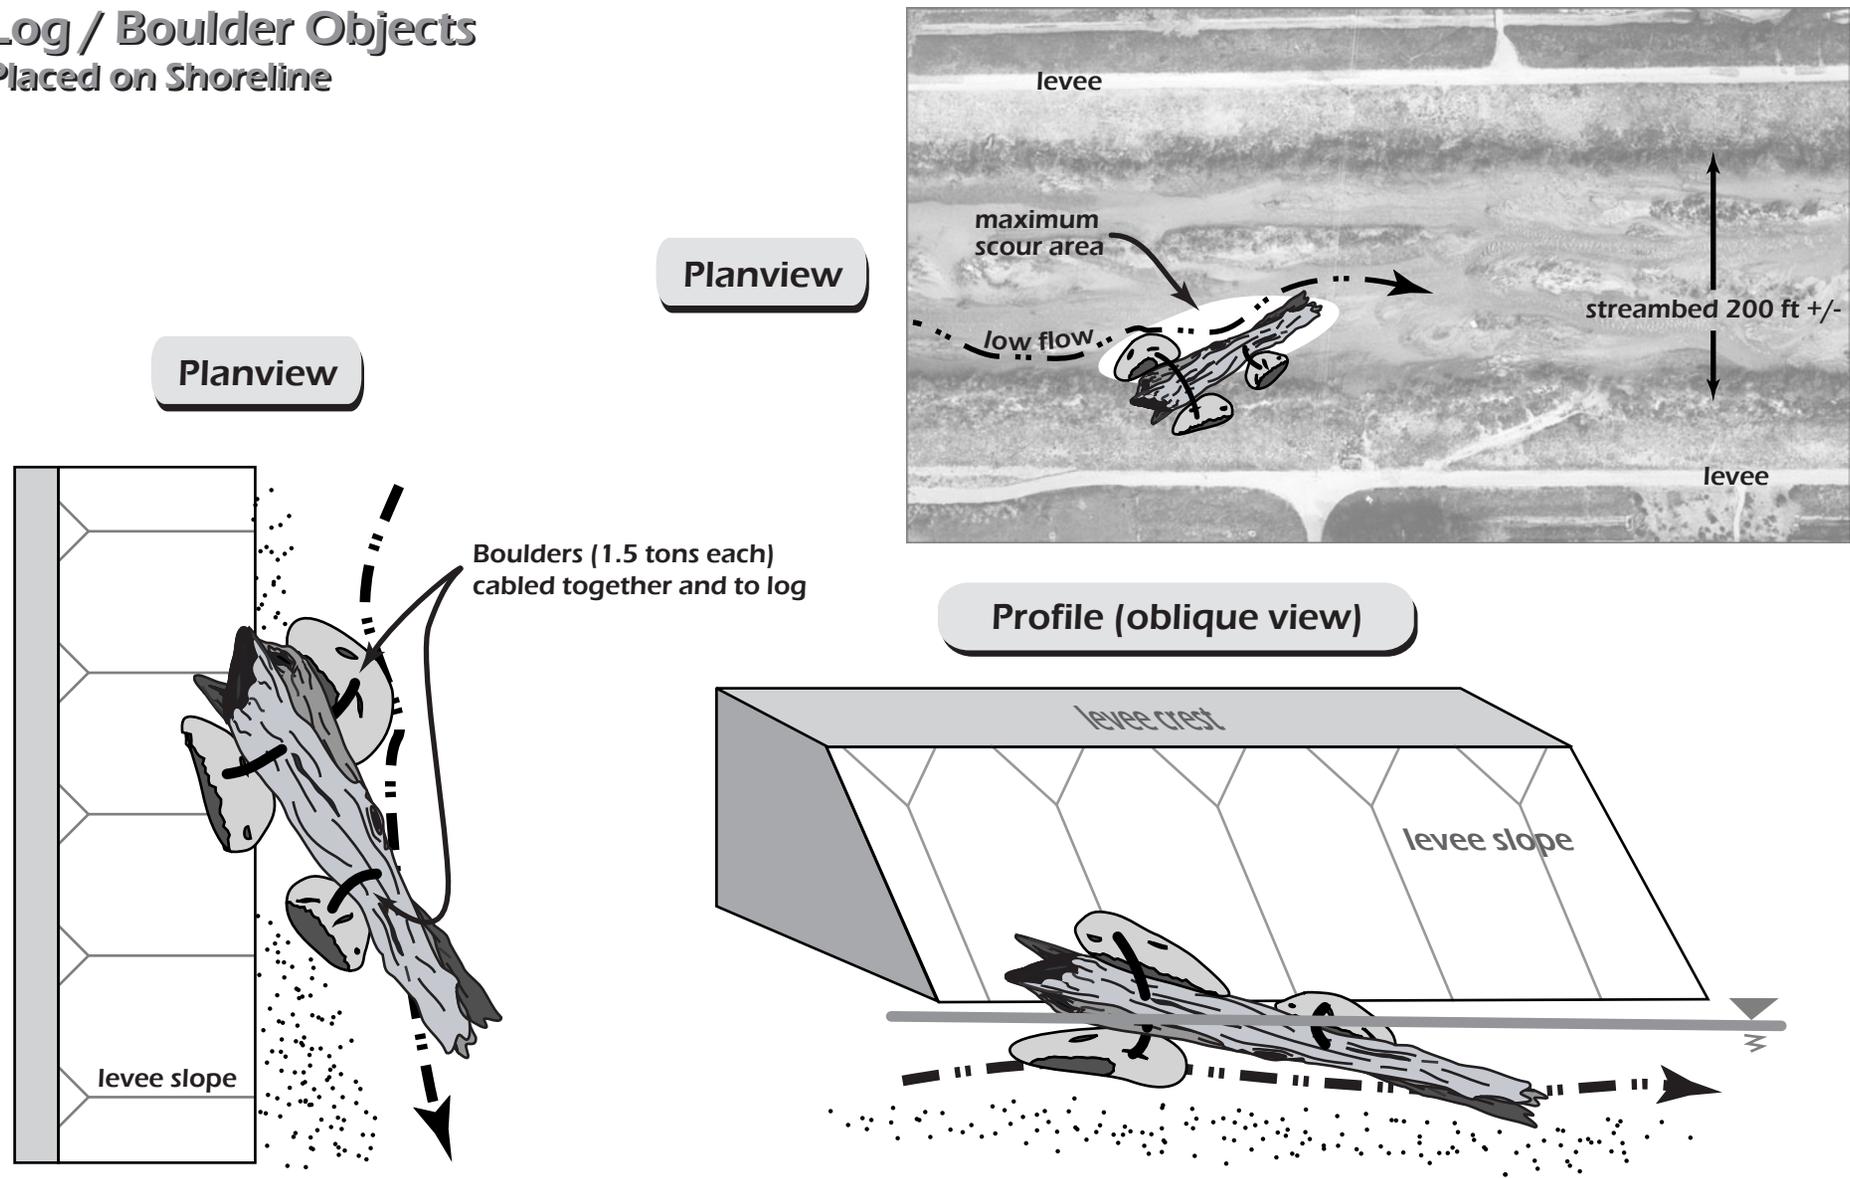
Log / Boulder Objects Placed on Shoreline

Figure 19: Plan and profile depictions of log / boulder structures placed along shoreline to induce bed scour and enhance instream habitat. Not to scale.

- **Bulrush/Cattail cobble structures at Shoreline:** The bulrush/cattail cobble structures are identical to the streambed versions with the exception that placement should occur at the shoreline. The structures should be placed where bank vegetation is degraded or non-existent and should be used as a stopgap for bank vegetation enhancement projects to provide cover and scour hole opportunities.

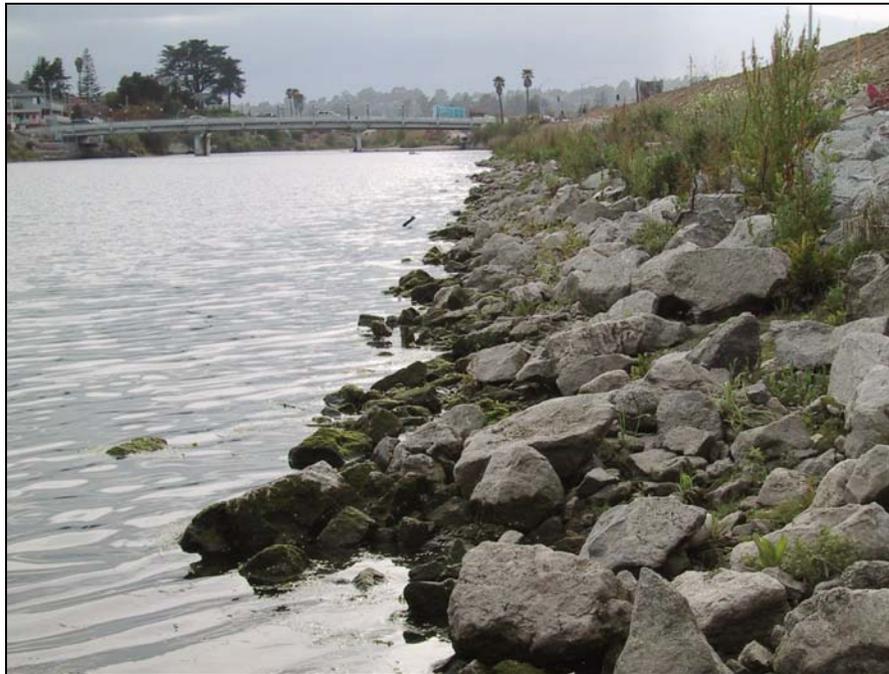
Example of current shoreline condition in the lower estuary reach

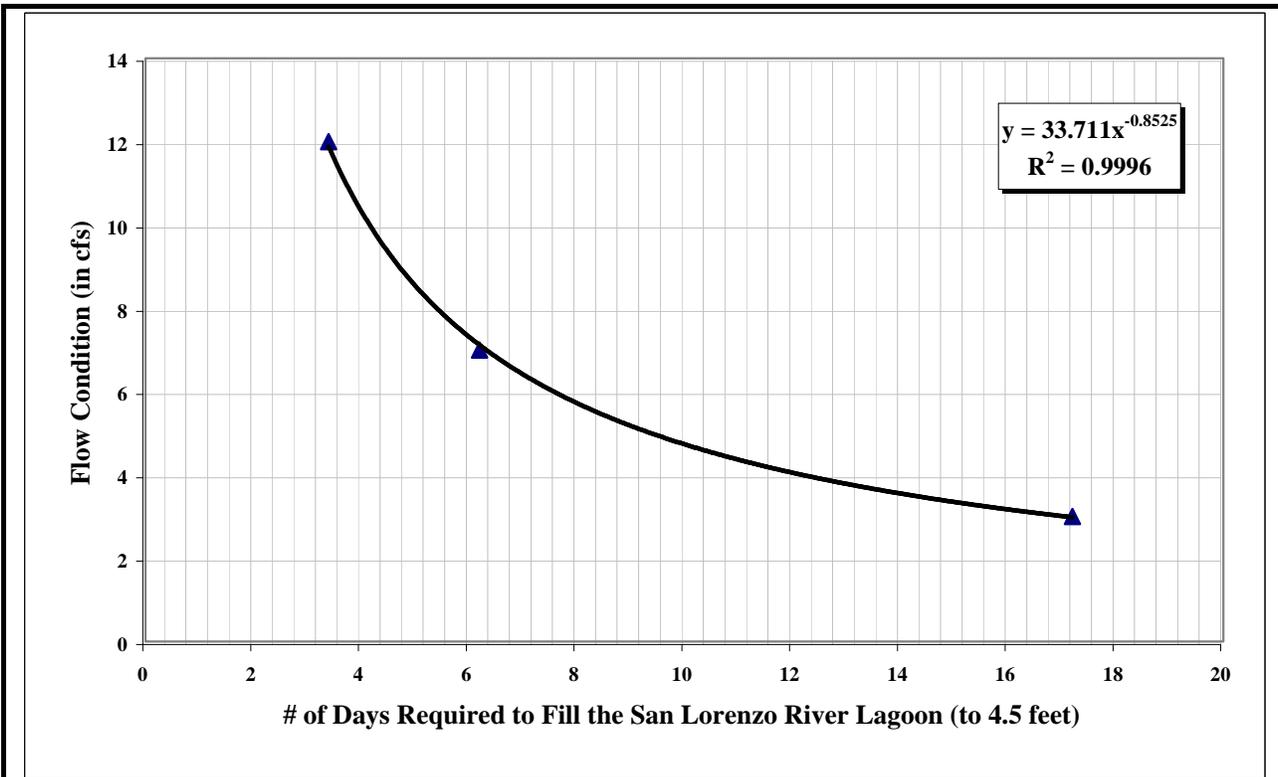
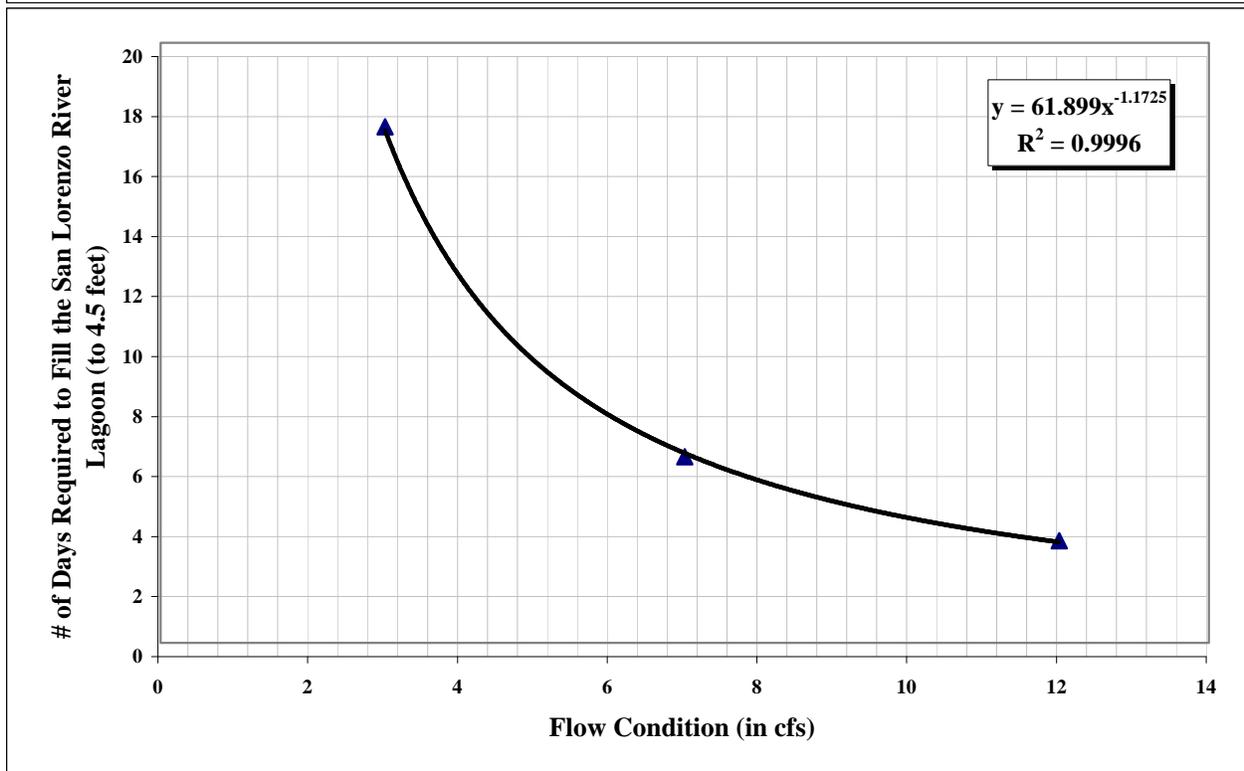
Figure B-1: Relationship between streamflow and number of days required to fill the lagoon. Both plots are shown so that future management can use either streamflow or # of days as input to determine the result in question.

A coarse water budget model was also developed for the lagoon to estimate the amount of time that would be required to fill the lagoon with freshwater under different flow conditions. These estimates are crucial in understanding the link between streamflow, timing of lagoon closure, late summer breaching events and overall lagoon water quality (see Appendix B for more details).

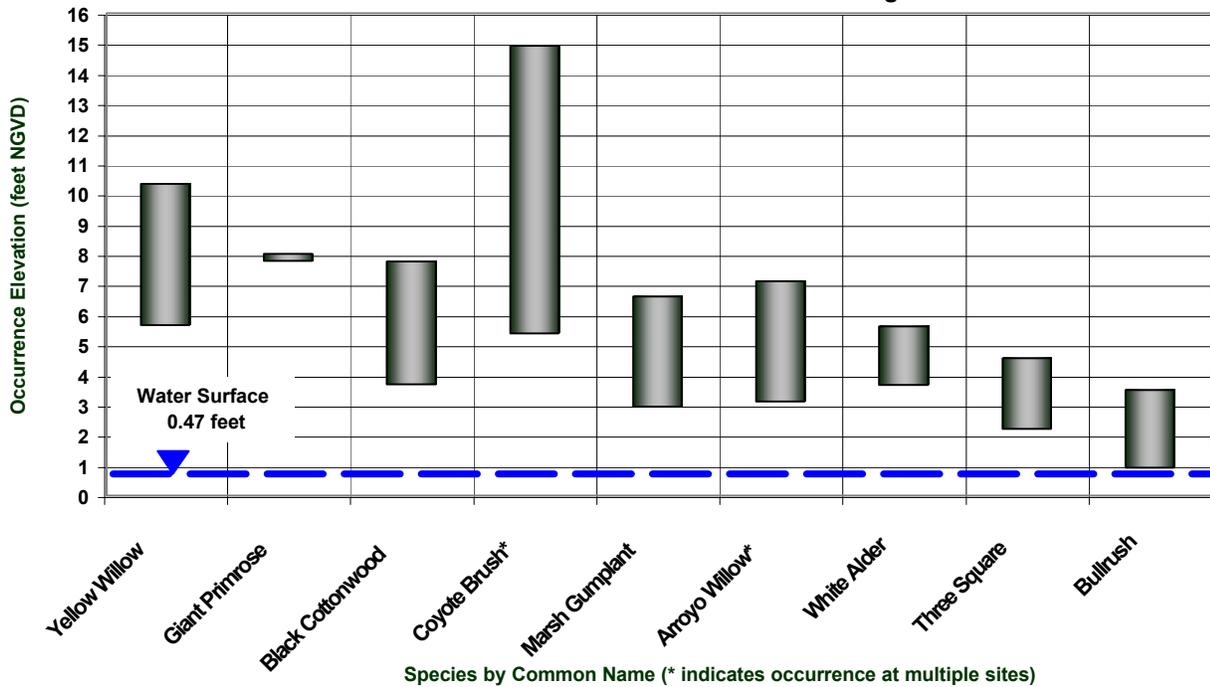
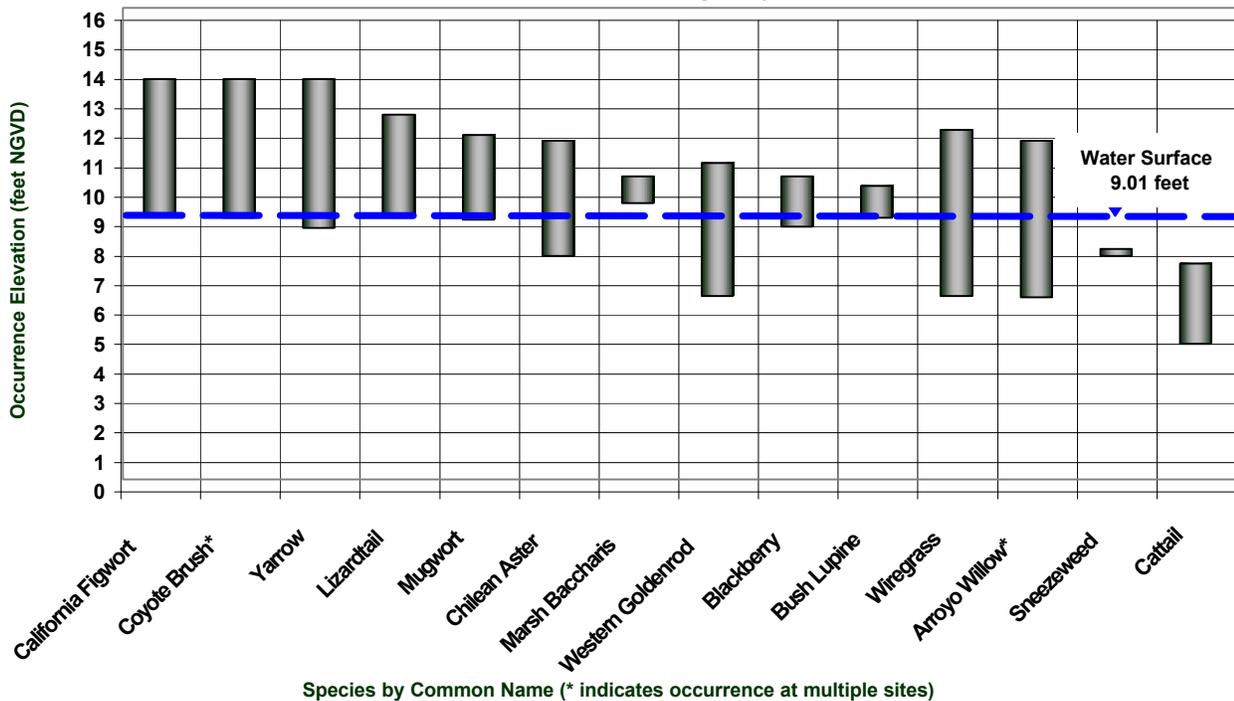
Appendix C: Elevation ranges for occurrences of riparian vegetation species from surveys at the San Lorenzo River and Scotts Creek, Santa Cruz County, California. The water surface elevation at the time of the survey is shown. Hydraulic conditions at Scotts Creek tend to create a perched system due to the narrow bridge where Highway 1 crosses the creek downstream of the marsh.
